1998 52' / 15.8m Viking Princess Flybridge Sport Cruiser

"Santasha"

Report of Marine Survey

Date Of Survey: 06/15/2026

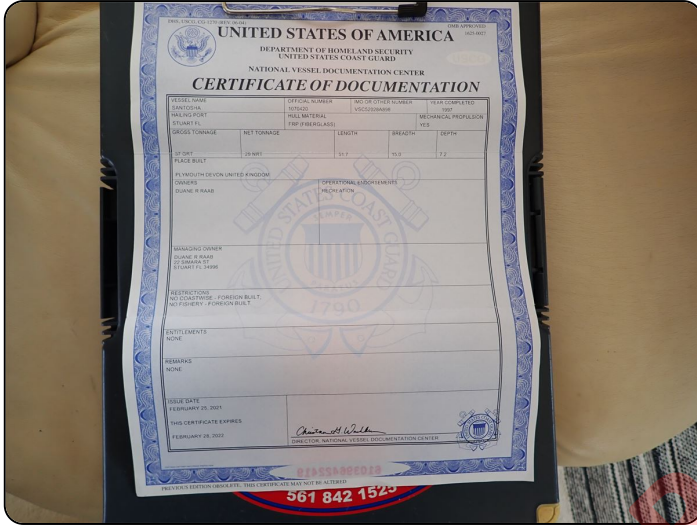
FINDING B-1

The vessel's U.S.C.G. Documentation was listed as current in the U.S.C.G. Documentation Online Database. The USCG Official Number 1070420 WAS NOT permanently displayed.

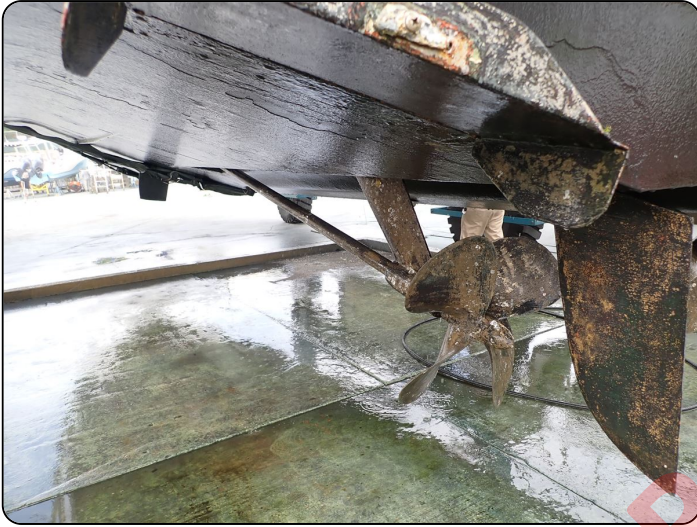
Two (2) bronze alloy, four bladed 24" x 17" pitch propellers with Prop Cap nut. Props had minor deformities when measured. Recommend prop tuning to improve efficiency.

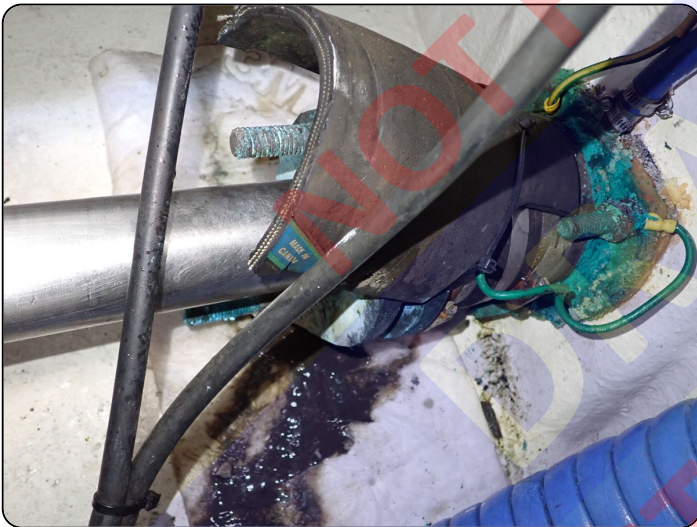
FINDING B-2

Shaft logs were bronze, mounted to the hull. The shaft log bonding connections need cleaning. The Shaft log bearings were considerably worn.

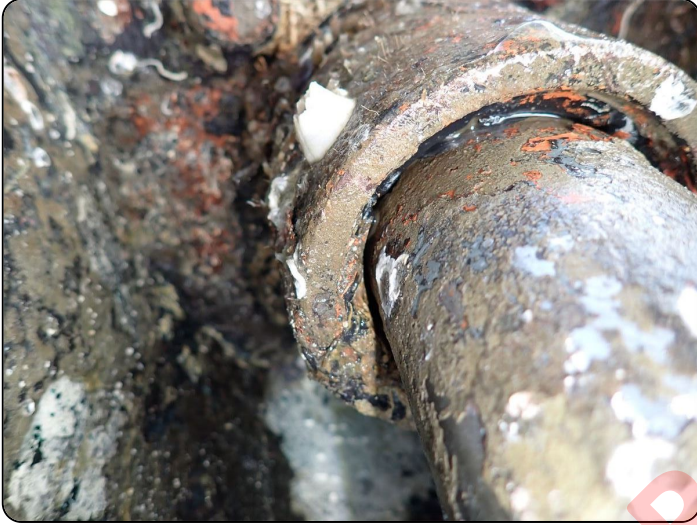
FINDING B-3

The shaft strut's Cutless Bearings had some significant wear/play.

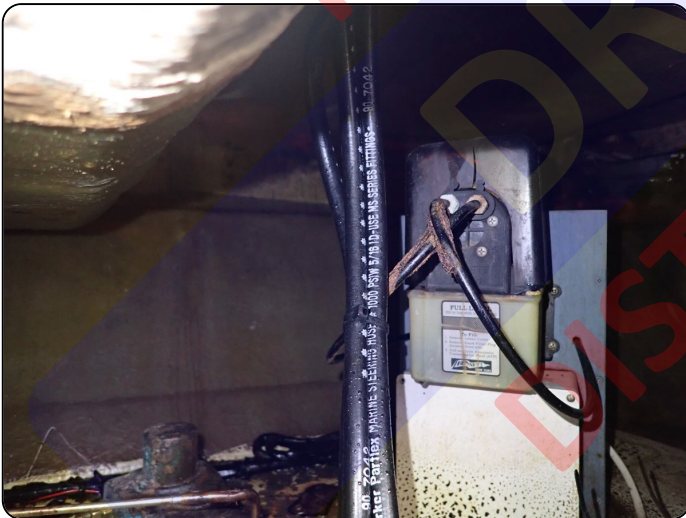
FINDING B-5

Replace the zinc anodes and anti fouling coatings at the next haul out. The port Trim tab did not operate. Starboard trim tab flexible reinforced hydraulic hoses have regraded connections at the pump.

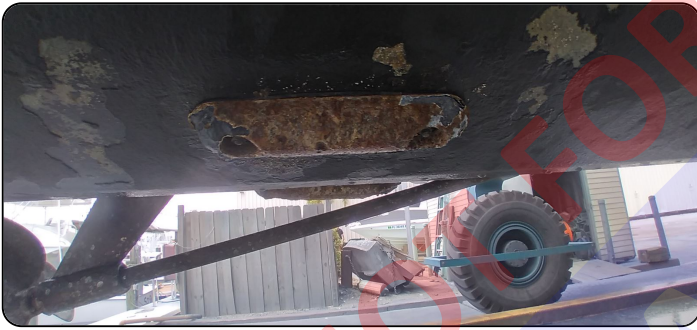
FINDING B-7

All underwater Zinc Anodes were significantly depleted and not effective. Recommend all internal bonding circuits of the exposed underwater hull metal components be serviced. There are several through hulls with no bonding connection or corroded terminal connections.

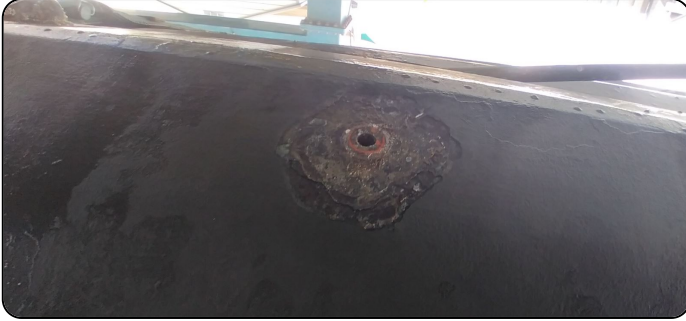
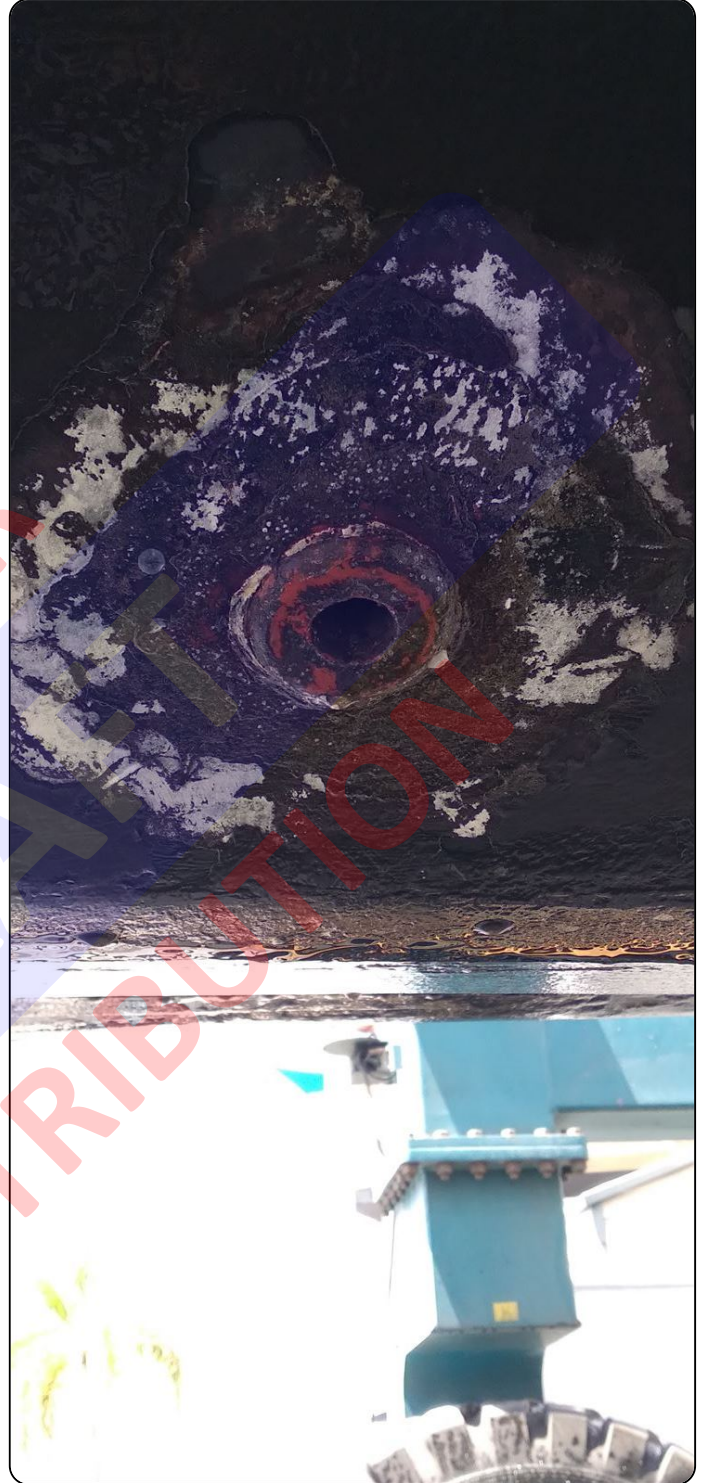
FINDING B-8

The antifouling bottom paint appeared to be at the end of its serviceable life and was flaking off/failing in several areas. The antifouling paints were failing rapidly due to insufficient bonding of the metal through hull fittings. Anti fouling paints are conductive. It appears there are several coats of anti fouling paint build up. It appears the hull bottom may not have been properly prepped for additional coats of anti-fouling paint. Recommend complete Hull bottom paint removal prior to new barrier coat and anti fouling paint application.

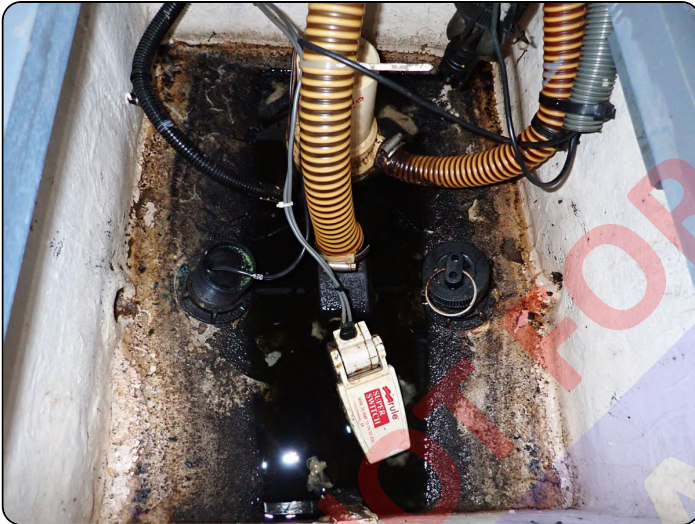
FINDING A-1

There was considerable debris and oil in the bilges. Oil discharged with bilge water can lead to serious Federal fines. This condition can foul the bilge pumps.

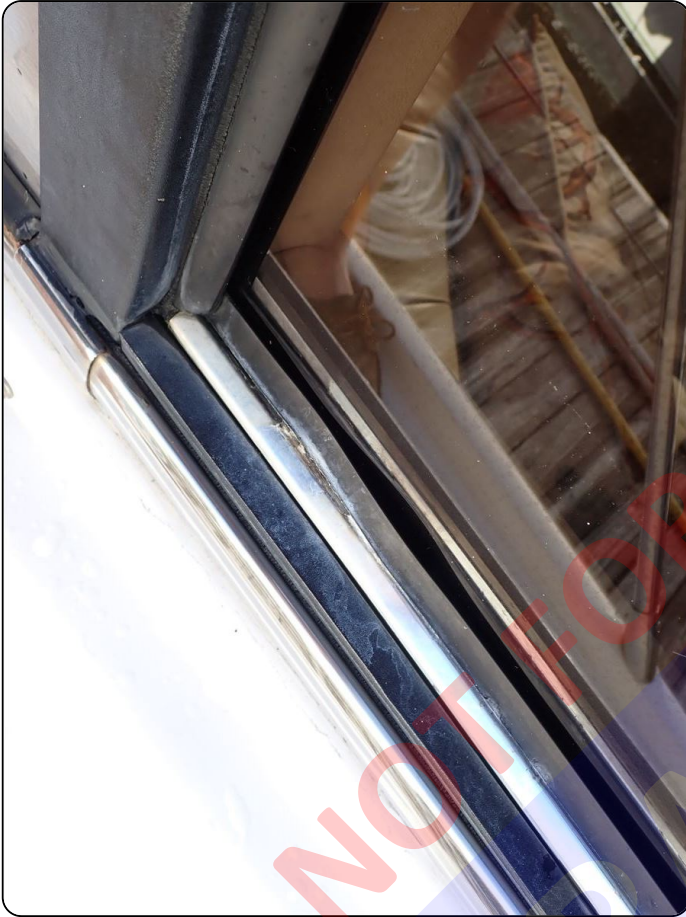
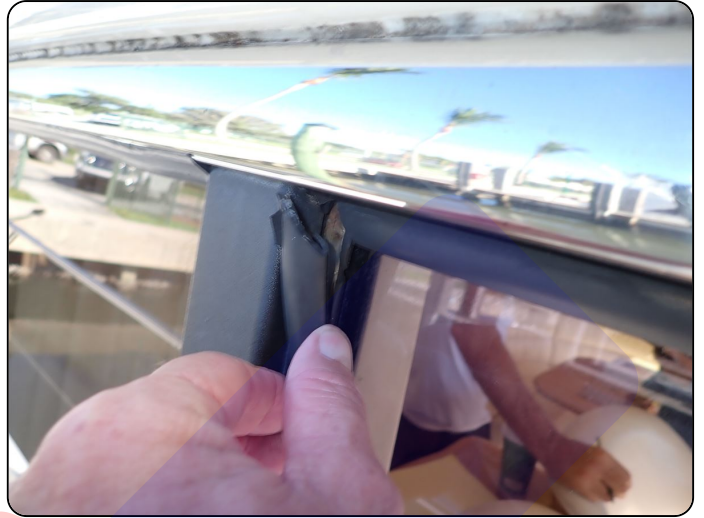
FINDING B-12

Tempered glass windshield with three (3) windshield wipers/washers. The wipers did not power up. The wiper blades were depleted due to UV exposure. The seals around the perimeter of the windshield glass had UV damage and separation from the windshield frame.

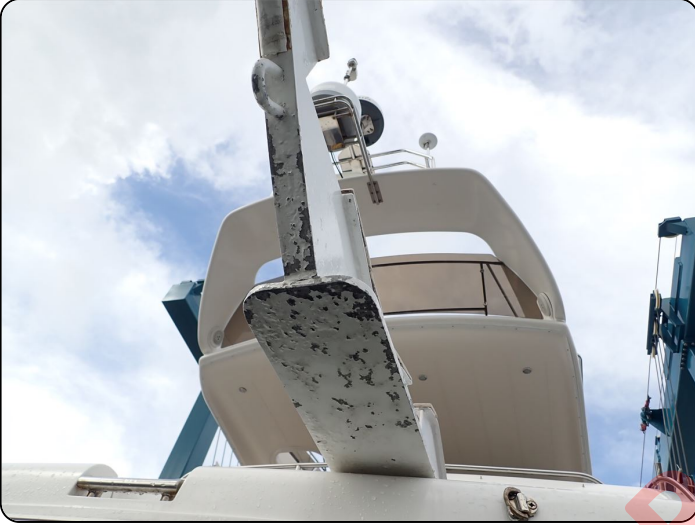
Dinghy davit on the swim platform was operated/demonstrated. The tender rack/chocks have extensive surface corrosion & flaking paint.

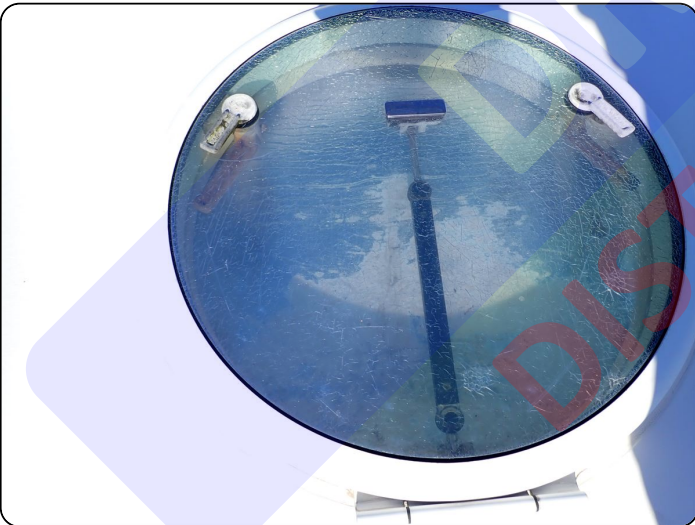
FINDING A-2

Access Hatch over Master Berth Plexiglass has extensive UV crazing & severely UV damaged hatch dogging handles. Deck hatch over the fly bridge stair case has extensive UV damage, appears to be seriously weakened. Hatch Support struts throughout vessel are weak and do not support the weight of the hatches.

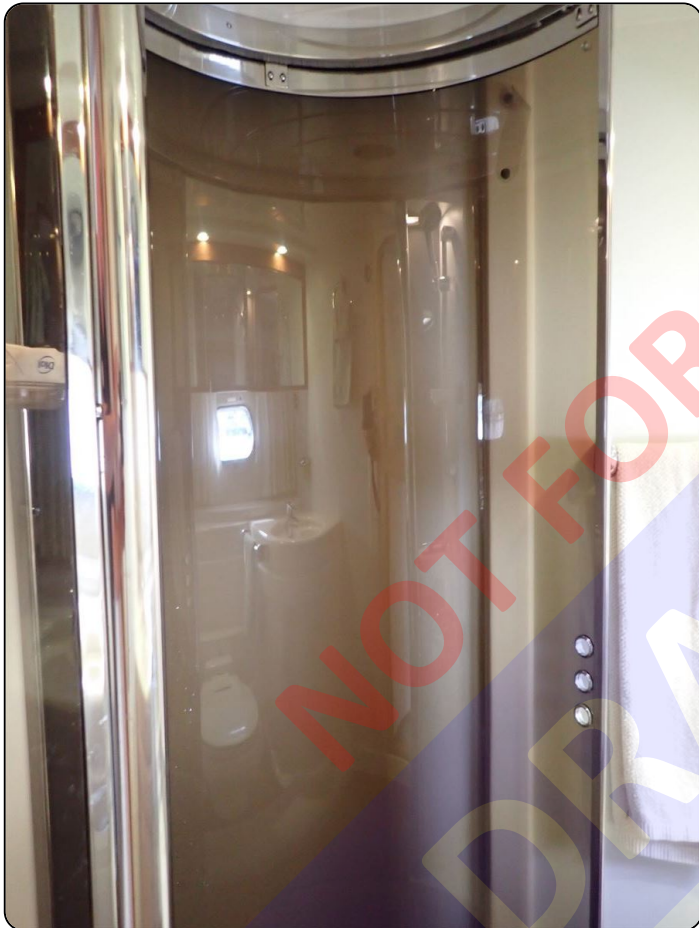
FINDING B-13

Stall shower in the Heads. The guest shower stall enclosure door jumped off the roller track when opened and closed.

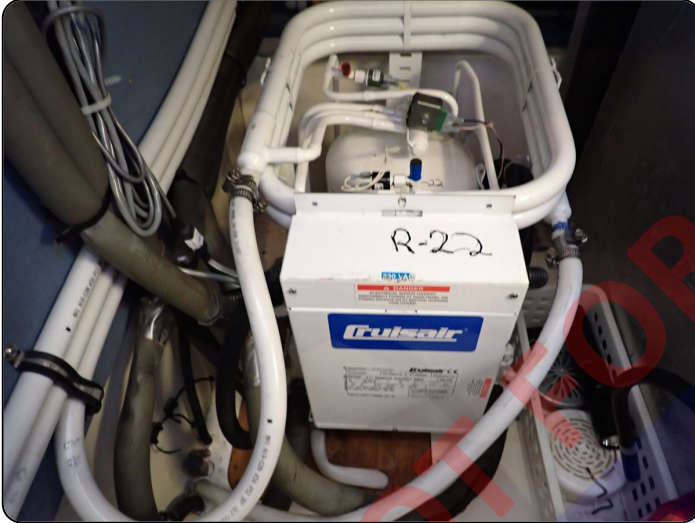
FINDING B-14

Four (4) Cruisair Marine Air units. (2) 16,000 BTU & (2) 12,000 BTU with digital controls. The Temperature Pull-Down appeared to be satisfactory. The #4 AC unit breaker would trip on shore power.

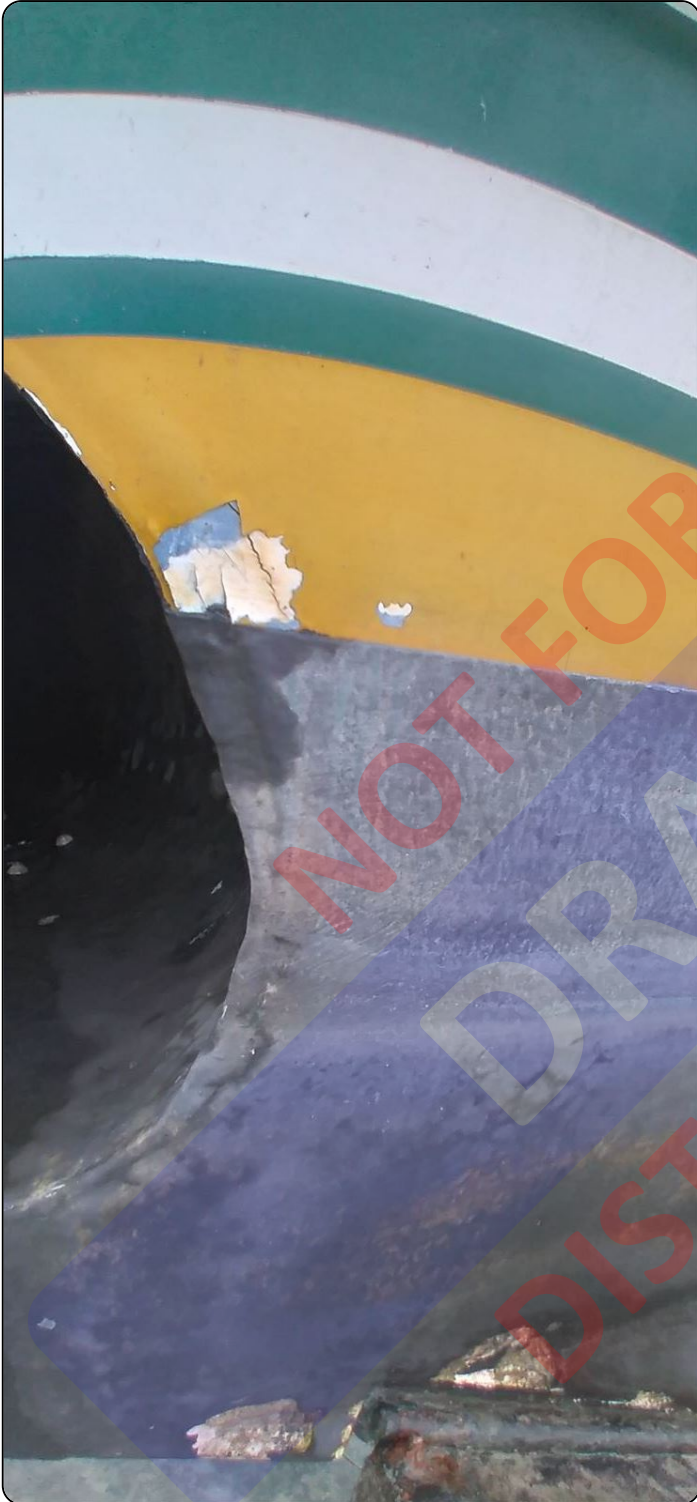
FINDING B-16

Raw water cooled with raw water/exhaust gas mixing risers, and flexible hoses to fiberglass surge pipes & mufflers, exiting through transom mounted discharges. The transom exhaust exits have surface cracking of faring compound around the perimeter of the opening.

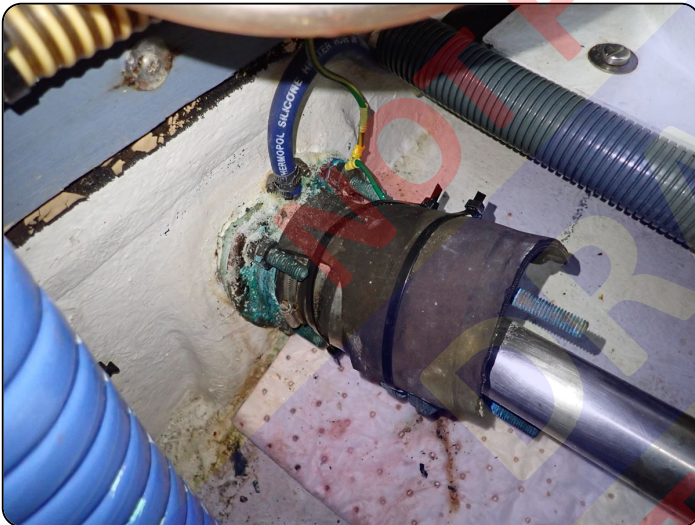
FINDING A-7

There was some fuel leakage found in the bilge in various places mainly on the starboard side of the machinery space.

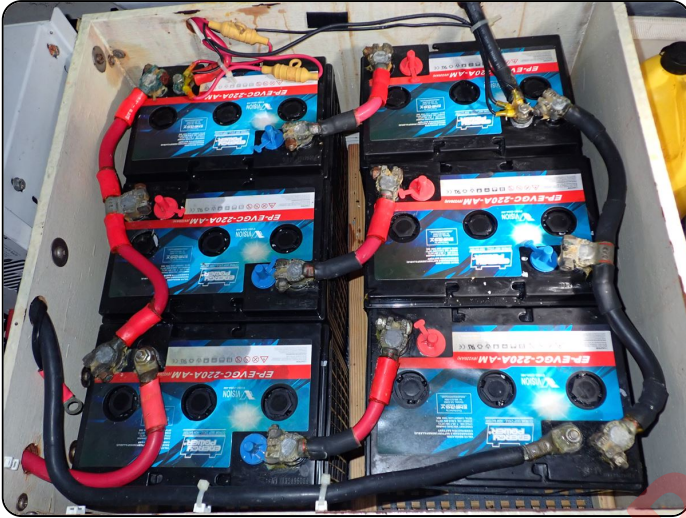
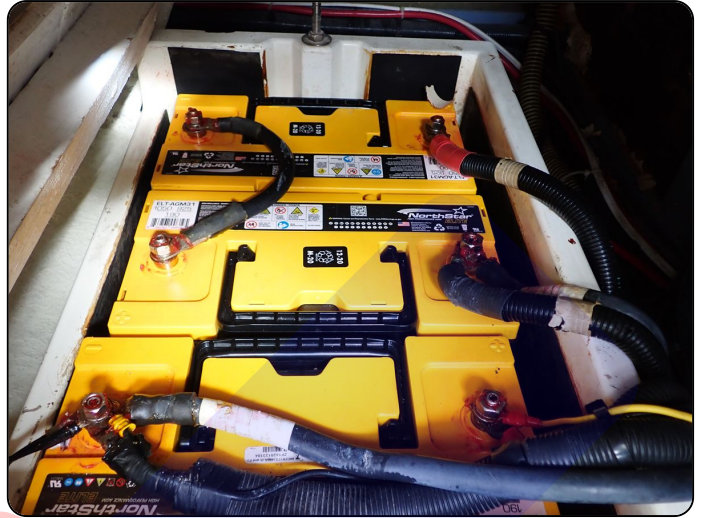
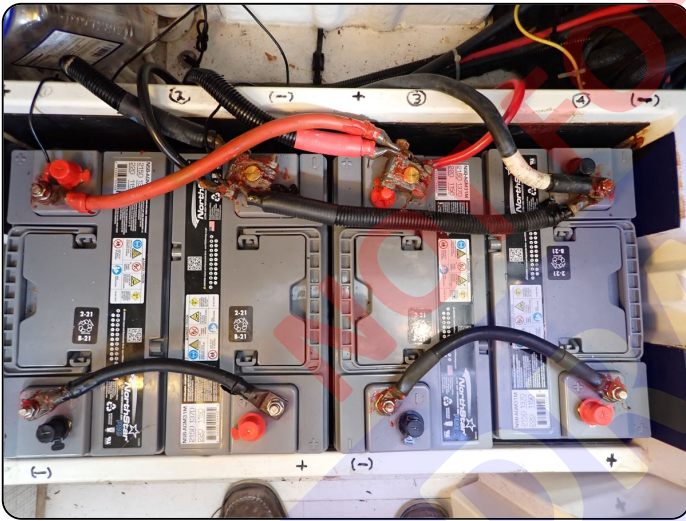
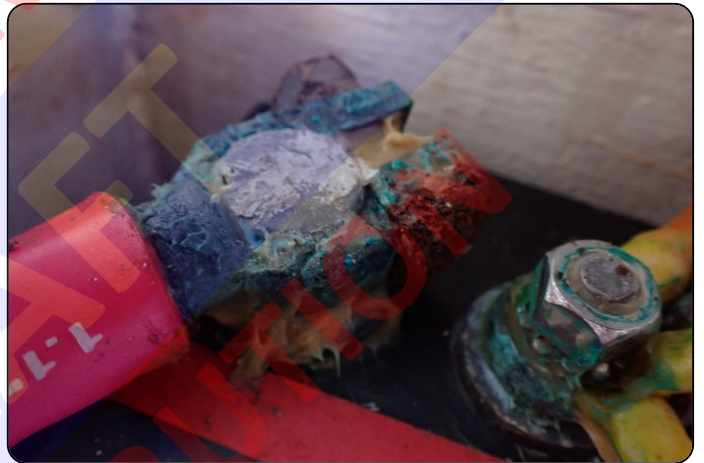
FINDING A-8

Adequate ventilation For 24 volt engine starting & 24/12 volt house systems. Exposed battery terminals require insulation or approved ABYC battery box covers. Some terminal connections need cleaning. Batteries well secured.

Batteries not labeled for operation. Battery installation dates not sighted. See maintenance records for battery installation dates.

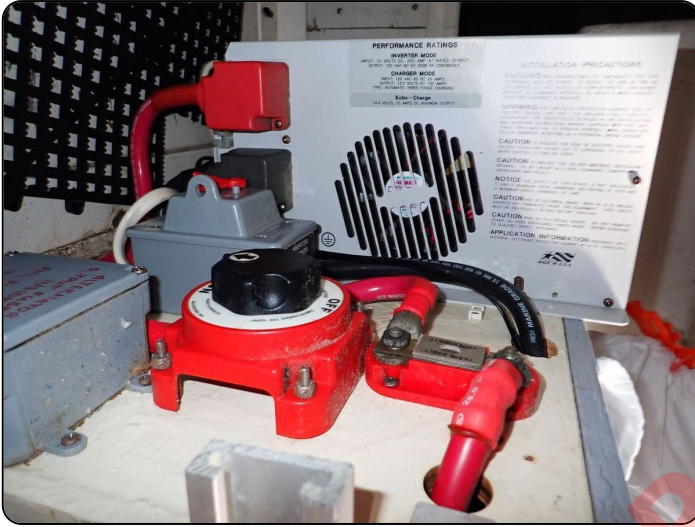
FINDING B-20

The battery switches were located in the engine space. Not considered readily accessible by current ABYC standards E-11. In the advent of a short or electrical malfunction in the engine space access to the battery switches could be dangerous safety hazard.

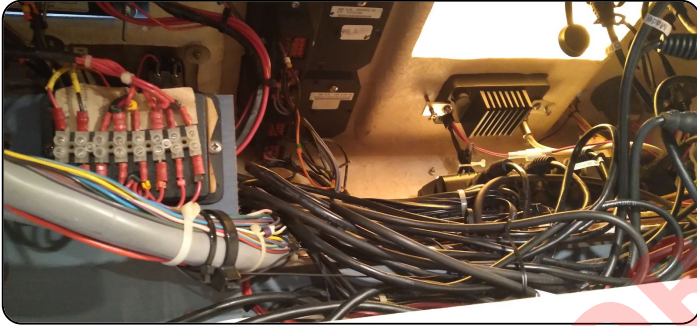
AC & DC wiring found to be unorganized, unsupported and unmarked in many locations.

Recommend thorough inspection and maintenance of the vessel's AC & DC wiring, (starting with the Anchor windlass power supply wiring and terminal connections) by checking the security of all electrical conductor terminations (destructive testing), cleaning any corrosion off of the electrical conductors and applying a corrosion inhibitor where appropriate.

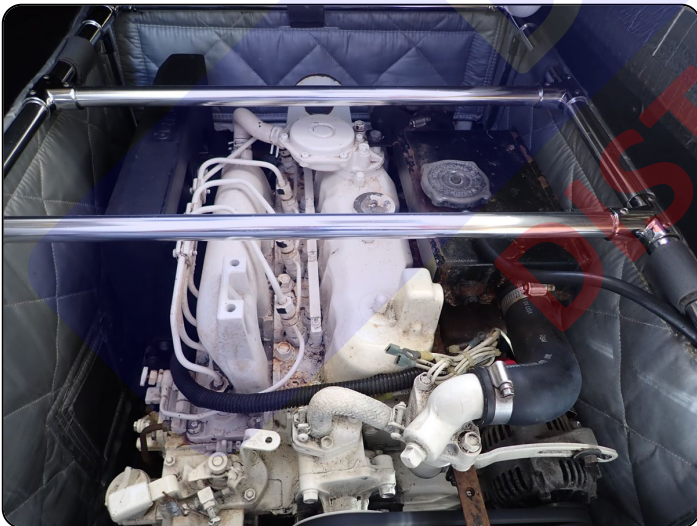
FINDING B-23

Not Tested. Reported to be Onan 15KW generator. See engine survey for complete details on the generator. Generator reported to be in unreliable condition by the Engine Surveyor.

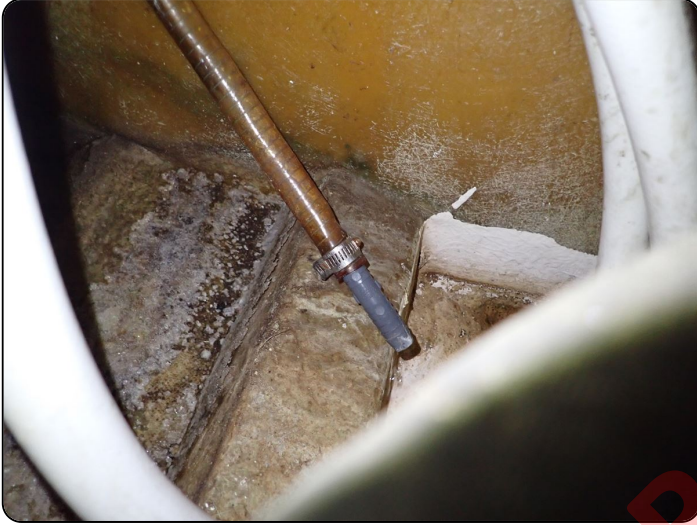
FINDING A-9

The Blackwater tank's vent fitting was undetermined . It appears the MSD vent pipe maybe disconnected from the hull fitting. Found unterminated pipe in location of the MSD hull side vent.

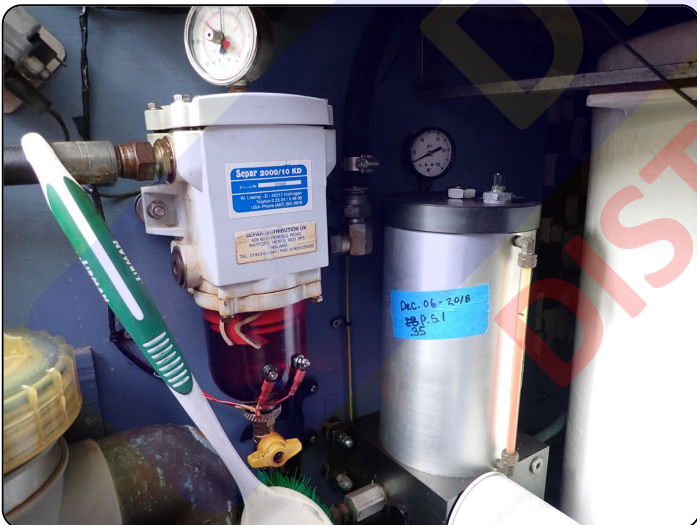
FINDING A-10

Hydraulic Power Steering. Reservoir air press low.

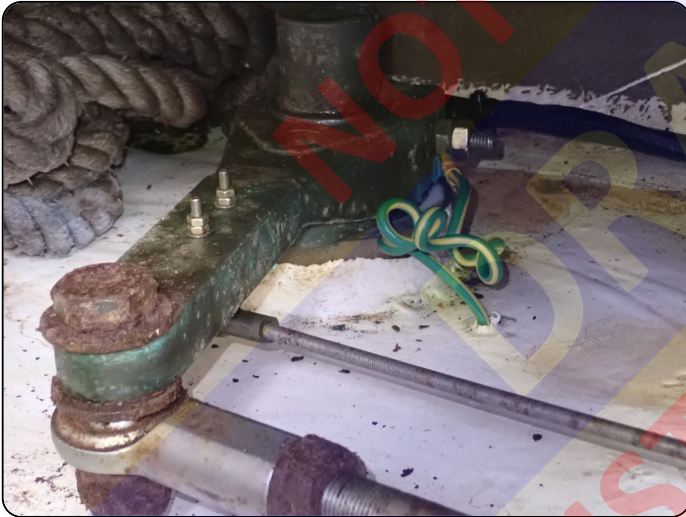
FINDING A-11

The steering ram mounting bracket/plate has significant surface corrosion. Steering connecting rod fasteners have excessive corrosion.

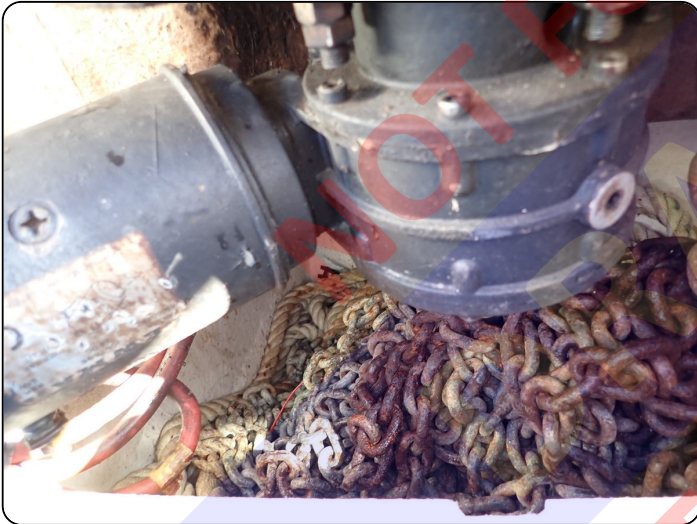
FINDING A-12

10Mm Galvanized chain. Chain corrosion appears excessive.

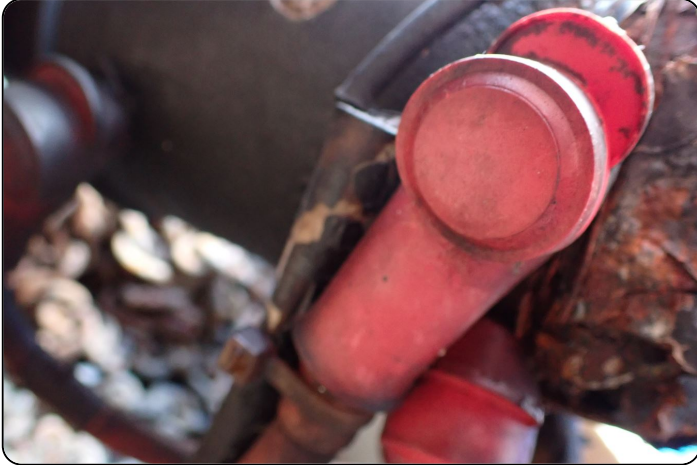
FINDING A-13

Lewmar 24-volt Windlass. Motor has bad electrical connections (significant corrosion) on Positive wire.

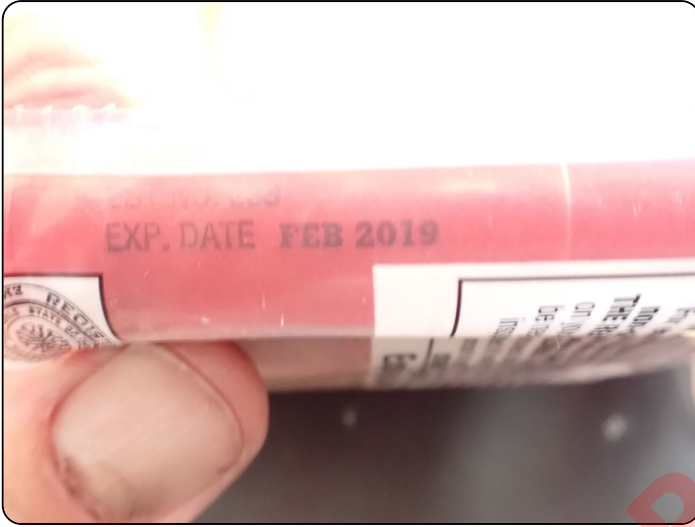
FINDING A-14

Expired.

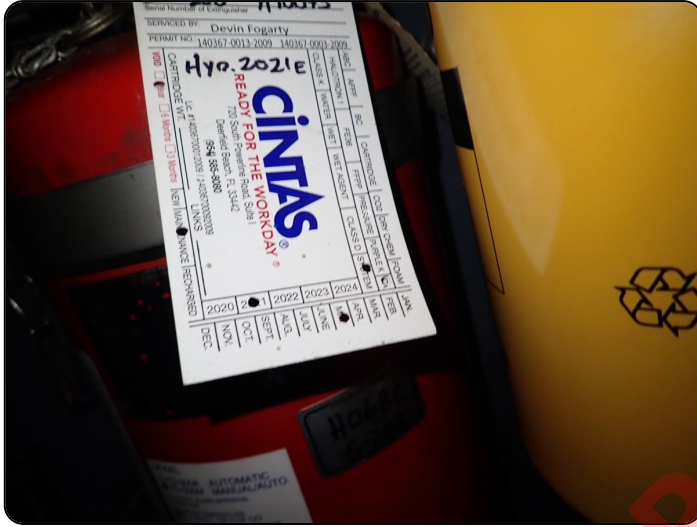
FINDING A-17

Inspection tags were observed. Exp. May 2022

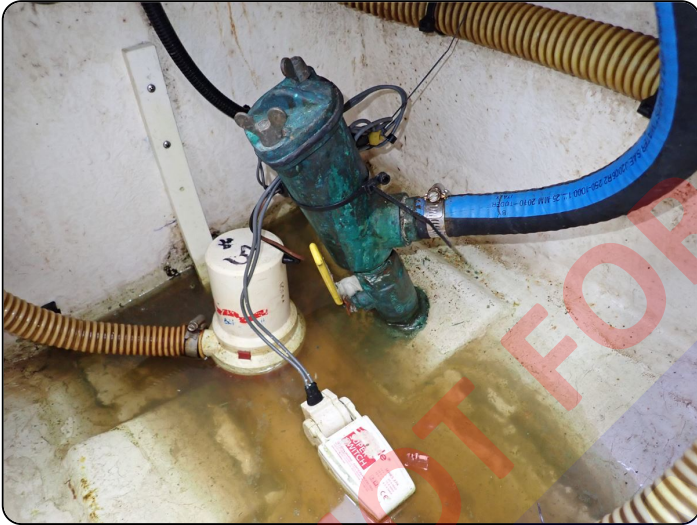
FINDING A-19

Four (4) Rule 2000, 24 volt Bilge Pumps with floatswitches. (2) Fore and Aft. Engine space bilges pumps power up on Float switches and manual switch at helm. The Mid Ship Bilge pump in the water tanks and holding tank space did not power up. The bilge pump located in the bow thruster compartment powers up from the manual switch and the float switch. The hose clamps and discharge plumbing on the bilge pumps appeared unobstructed. Access to the overboard discharge fitting connection was limited for inspection. The 3 operational pumps observed pumped water overboard from an above the waterline through hull. Further inspection required to determine the Midship pump overboard discharge is connected properly.
