### PRE-PURCHASE CONDITION & VALUE SURVEY

#### 2018 Pursuit S 408 Sport

Triple Yamaha F350NCC • HIN SSUC1050I718 • USCG Official No. 1296219

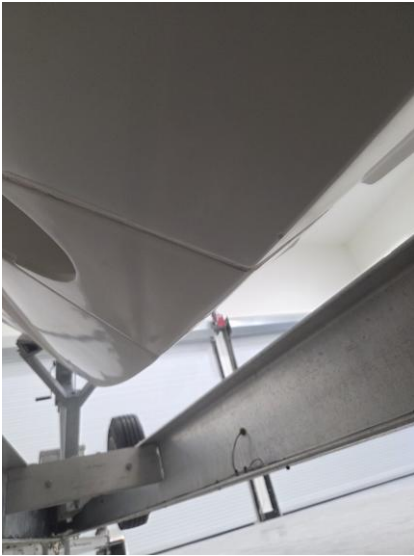
**03** Hull examined out of the water by phenolic-hammer sounding and Tramex Skipper moisture meter; no blistering, delamination, significant abrasion or prior damage sighted.

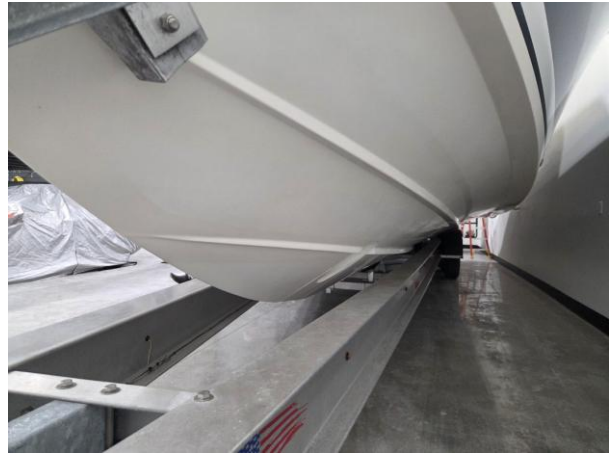
**04** Hull bottom clean; bare gel coat, no antifouling; no damage sighted.

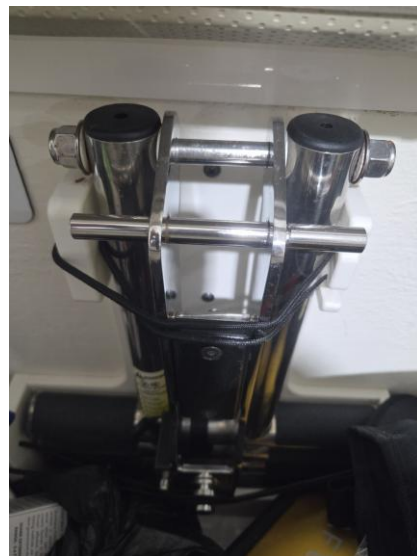
47 Dive-door boarding ladder secured (latch adjustment noted, DEF-11).

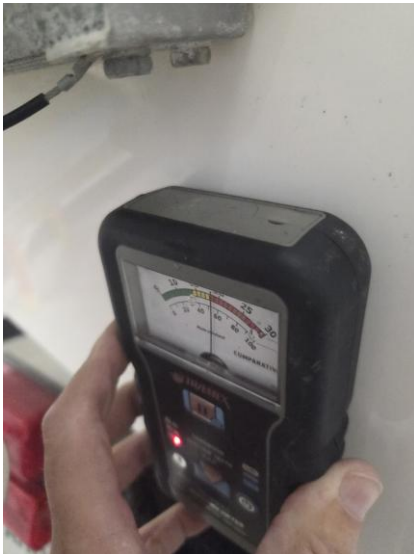
| # | Item / Location | Finding | Recommendation | Priority |
|---|---|---|---|---|
| 1 | Transom — engine-mount area | Elevated moisture-meter reading (Tramex Skipper) at the transom in the engine-mounting area; the balance of the hull sounded and metered dry with no blistering or delamination. Reading is reliable — bare gel coat, no antifouling. | Investigate the transom laminate and core for moisture intrusion at the next haul-out; identify and seal the ingress path (engine-mount fasteners, bracket bedding, rigging penetrations). Re-survey the transom moisture before binding coverage. Cross-ref Item 2 (corroded steering-arm bracket fasteners in the same area). | Priority |

57 DEF-1: Elevated moisture-meter reading (Tramex Skipper) at the transom, engine-mount area.

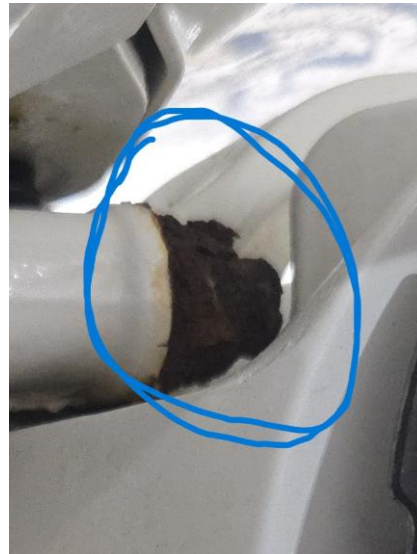
| # | Item / Location | Finding | Recommendation | Priority |
|---|---|---|---|---|
| 2 | Outboards — steering-arm clamps & bracket fasteners (all 3) | Severe corrosion on the steering-arm connection clamps and bracket fasteners on all three engines (Yamaha F350NCC Bracket 2). Access to the steering arms most likely requires removal of the powerhead, so replacement is potentially extensive and costly in labor across all three engines. | Have an authorized Yamaha dealer disassemble, evaluate and renew the corroded clamps and fasteners; confirm steering-arm security and correct torque. Obtain a written labor estimate — powerhead removal is most likely required to access the arms. Address before closing. Cross-ref Item 1 (transom moisture, same area). | Priority |

58 DEF-2: Severe corrosion on the steering-arm connection clamp, typical of all three engines.

minor fastener job — access to the steering arms on the F350 most likely requires removal of the powerhead, so replacement on all three engines is potentially extensive and costly in labor, and that exposure is borne across the whole rig. Weighed alongside these is the engines' operating profile now visible in the diagnostic downloads: a meaningful share of cruise time in the 3,500–4,200 rpm harmonic band, which brings the Yamaha F350 flywheel service (the flywheel advisory in Section 5) into nearer view and represents a further budgeted expense on all three engines. Together with the weak battery bank and the inoperative comfort systems, these factors more than offset the premium the low hours and heavy equipment would otherwise command. Reconciling the two approaches against this deficiency and near-term-service burden, it is the surveyor's opinion that the fair market value is \$430,000.

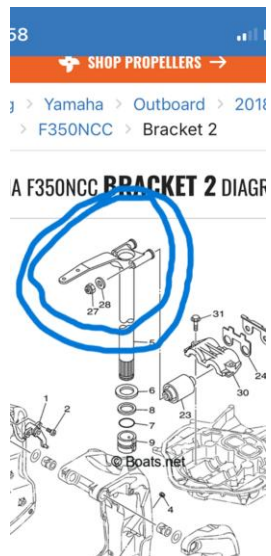
59 DEF-2: Reference — Yamaha F350NCC 'Bracket 2' parts diagram identifying the affected steering-arm bracket and fasteners.

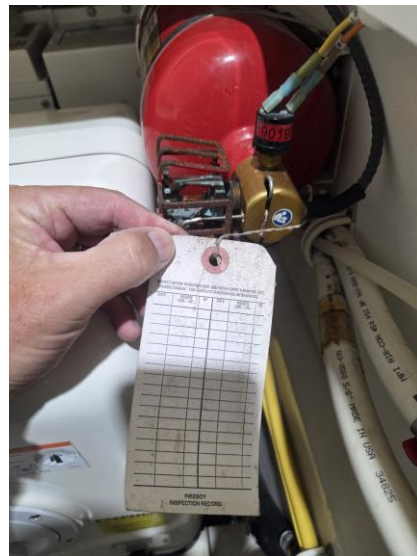
60 DEF-3: Fixed fire-suppression system with no current annual inspection tag.

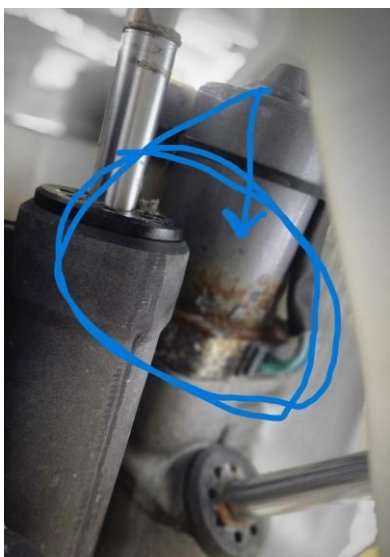
| # | Item / Location | Finding | Recommendation | Priority |
|---|---|---|---|---|
| 6 | Outboards — trim/tilt motor cases (all 3) | Corrosion on the power trim/tilt motor cases on all three engines. | Clean, treat and protect the motor cases; have a Yamaha dealer confirm no water intrusion at the motor seals; monitor for progression. | Recommend |

61 DEF-6: Trim/tilt motor case corrosion, typical of all three engines.

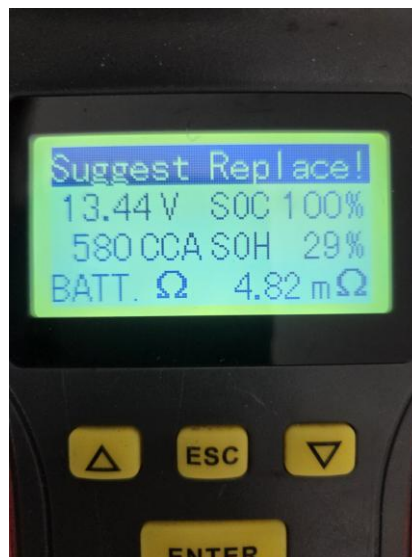
On load testing, six batteries returned a low state of health (ranging from 24% to 58%; one unit indicated “Suggest Replace” at 29%). This is carried into the Schedule of Deficiencies as Item 7, with replacement recommended. AC generation is by the Fischer Panda 7.0 kW diesel set (ABYC A-27), which is addressed under Section 9.

| # | Item / Location | Finding | Recommendation | Priority |
|---|---|---|---|---|
| 7 | DC batteries (6) | Six batteries load-tested with a low state of health (24–58%); one indicated “Suggest Replace” at 29%. | Replace the weak batteries; confirm charging-system output and that battery types are not mixed within a bank (ABYC E-10). | Recommend |

62 DEF-7: Battery load test — 'Suggest Replace,' state of health 29% (bank range 24 to 58%).

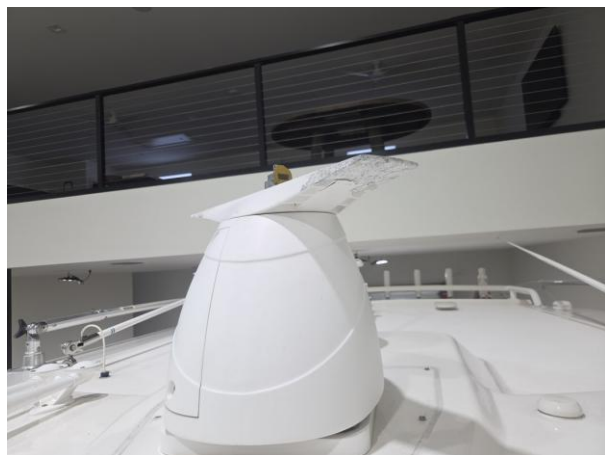
| # | Item / Location | Finding | Recommendation | Priority |
|---|---|---|---|---|
| 8 | Radar / antenna support base | Significant corrosion at the radar / antenna support base on the hardtop. | Clean and treat, or renew, the base and fasteners; confirm mount integrity and seal the penetrations against water intrusion. | Recommend |

63 DEF-8: Significant corrosion at the radar / antenna support base.

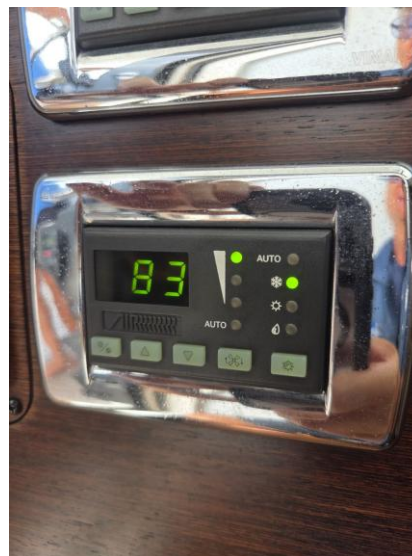
| # | Item / Location | Finding | Recommendation | Priority |
|---|---|---|---|---|
| 9 | Air conditioning — No. 2 (upper-deck) | No. 2 upper-deck A/C did not produce cold air (control read approx. 83 °F); No. 1 cabin unit output 69 °F (satisfactory). | Have a marine HVAC technician diagnose the No. 2 unit (refrigerant charge, compressor, seawater flow) and repair. | Recommend |

64 DEF-9: Upper-deck (No. 2) air-conditioning control read approximately 83 degrees F; unit did not produce cold air.

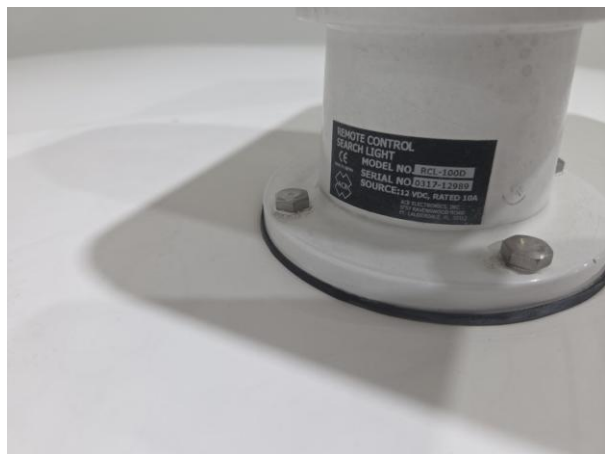
| # | Item / Location | Finding | Recommendation | Priority |
|---|---|---|---|---|
| 12 | ACR searchlight (RCL-100) | One LED element out in the ACR searchlight. | Replace the affected LED element/module; confirm full output and remote control. | Monitor |

65 DEF-12: ACR searchlight base; one LED element out.

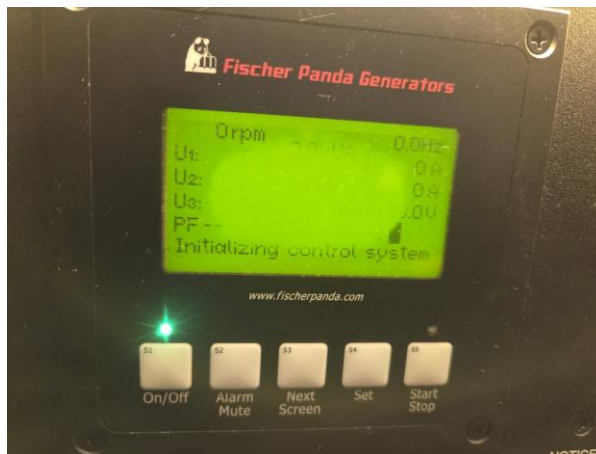
| # | Item / Location | Finding | Recommendation | Priority |
|---|---|---|---|---|
| 14 | Generator control display | Generator control-panel display degraded / hard to read (generator otherwise tested satisfactory under load). | Have Fischer Panda service renew the display module; monitor for control-system faults. | Monitor |

66 DEF-14: Generator control-panel display degraded / hard to read.

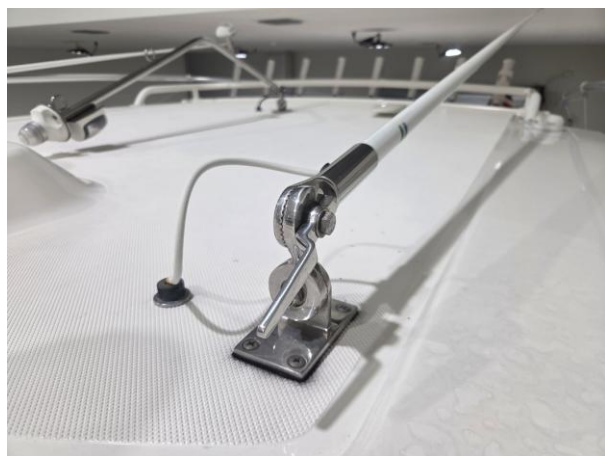
| # | Item / Location | Finding | Recommendation | Priority |
|---|---|---|---|---|
| 15 | VHF antenna coax | VHF antenna coaxial cable exposed at the base with no UV protection. | Sleeve, seal and provide UV protection to the coax and connector to prevent UV degradation and water ingress. | Monitor |

**67** DEF-15: VHF antenna coax exposed at the base with no UV protection.
