## TB MARINE SURVEYORS

### PRE-PURCHASE CONDITION & VALUE SURVEY

1990 Island Packet 35 Cutter “Nirvana”

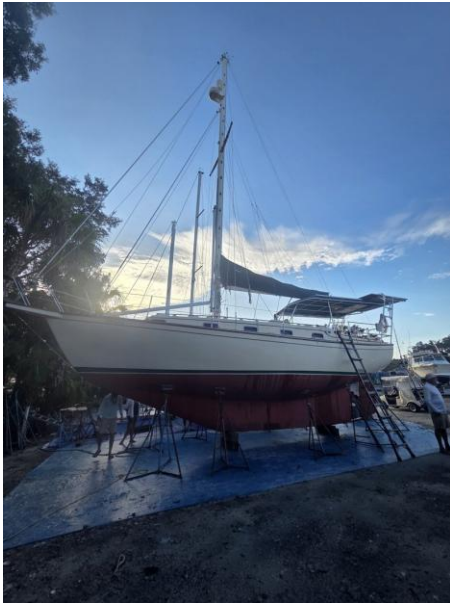
**06** Vessel inspected out of the water — port side profile. Hull bottom tested with phenolic hammer and moisture meter, no exceptions

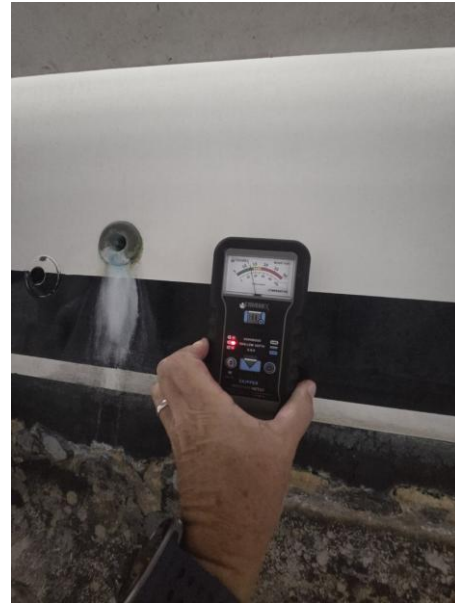
**07** Hull sides tested with a moisture meter — no elevated readings

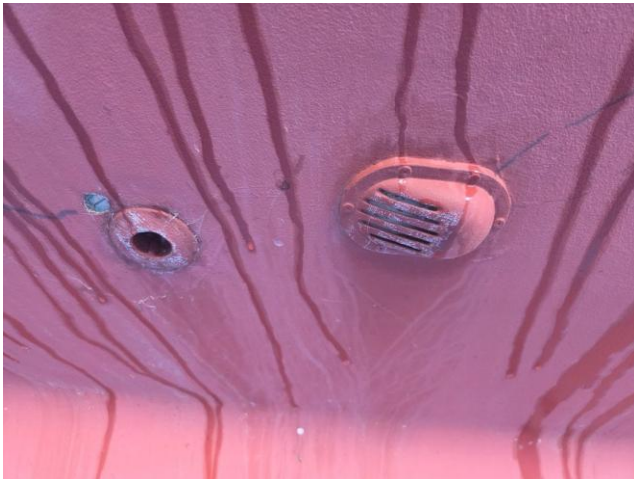
**08** Hull bottom clean; thru-hulls clean and corrosion-free

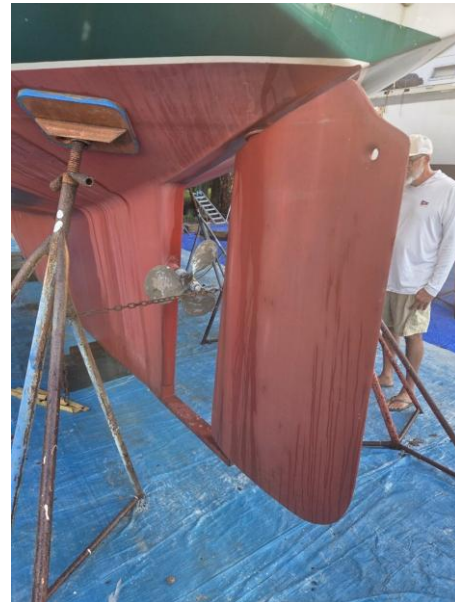
**09** Rudder in very good condition; operates through full range

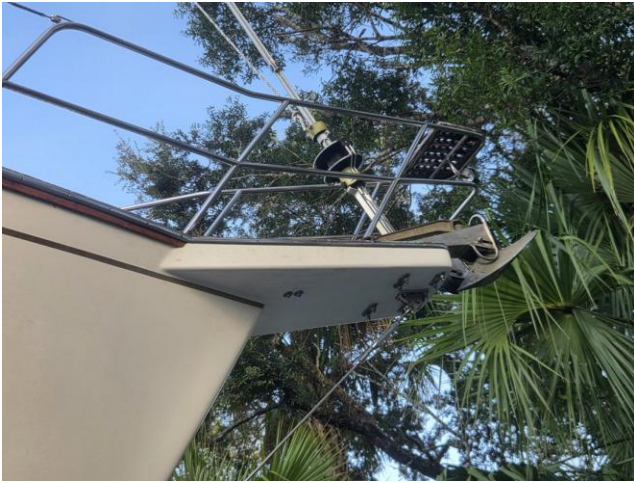
**10** Hull-integral bowsprit — very solid

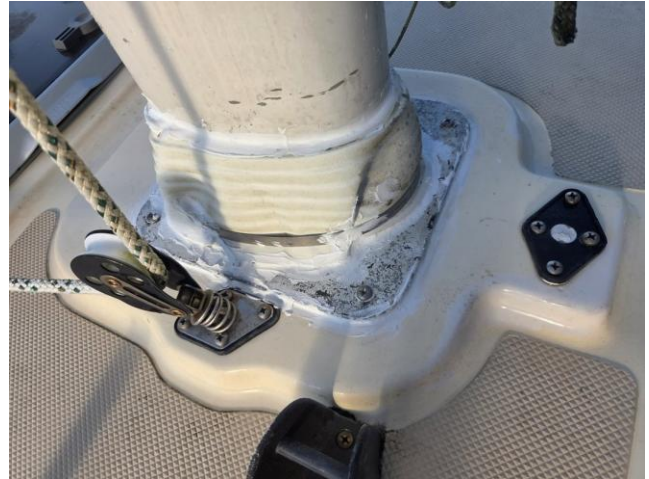
**13** Mast partner well sealed; no leaks observed from the interior

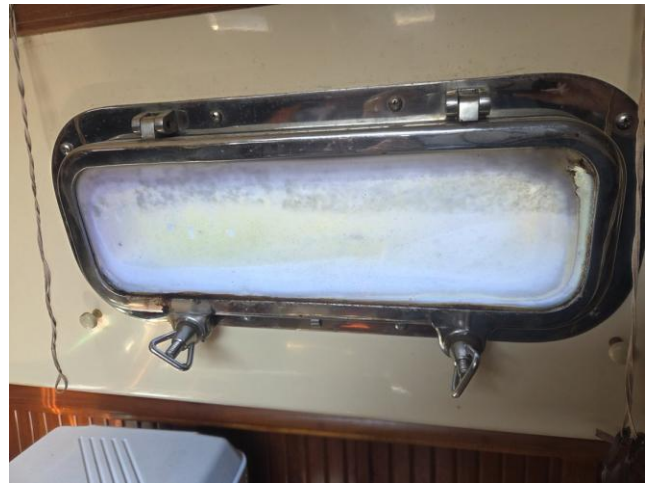
The salon portlights have stained, UV-weathered glazing; the aft salon ventilation hatches do not open fully; and the exterior brightwork requires refinishing. These are scheduled as Monitor items.

15 DEF Salon portlights have stained, UV-weathered glass

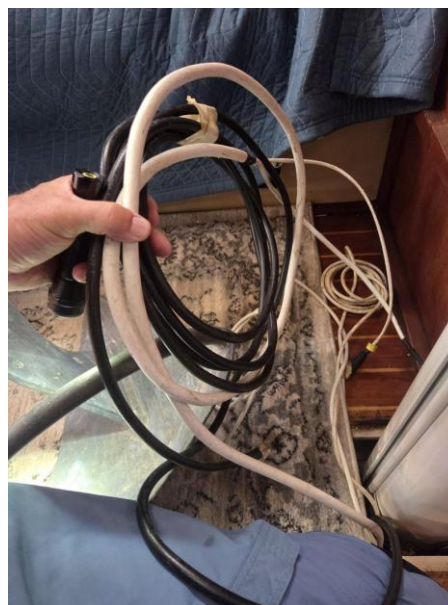
**23** DEF Mast wiring not routed into the mast

| # | Item / location | Finding | Recommendation | Priority |
|---|---|---|---|---|
| 6 | <b>Mast wiring not connected</b> | Wiring for the VHF antenna, radar, spreader lights and wind instruments is not routed up the mast; the mast-mounted equipment is therefore not powered or connected. <i>(Photo 23)</i> | Re-run and connect the mast wiring (best done with the rigging inspection recommended in Section 5). Until then, confirm that the vessel displays the navigation lights required for operation under power and at anchor, and that a working VHF antenna is fitted, before any night or offshore use. Reference ABYC E-11 and A-16. | <b>Priority</b> |

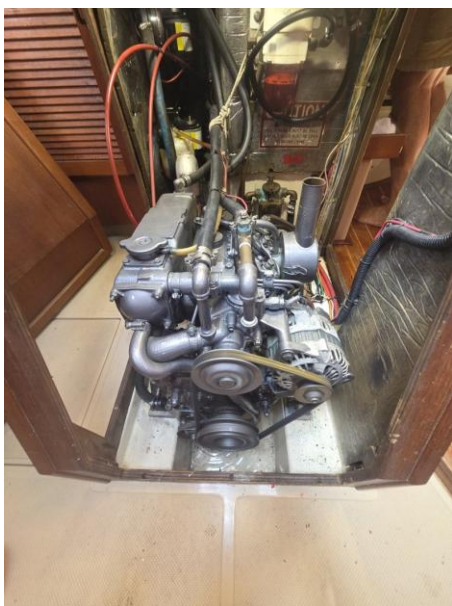
**24** Yanmar 3HM35F — ran well during the sea trial

| # | Item / location | Finding | Recommendation | Priority |
|---|---|---|---|---|
| 7 | <b>Engine identification</b> | The engine model and serial data plate is not affixed to the engine, and the serial number stamped on the block is not accessible. The engine serial number could not be recorded. <i>(Photo 24)</i> | Locate and record the block serial number at the next service (needed for parts, warranty and insurance) and affix a replacement identification plate. | <b>Recommend</b> |

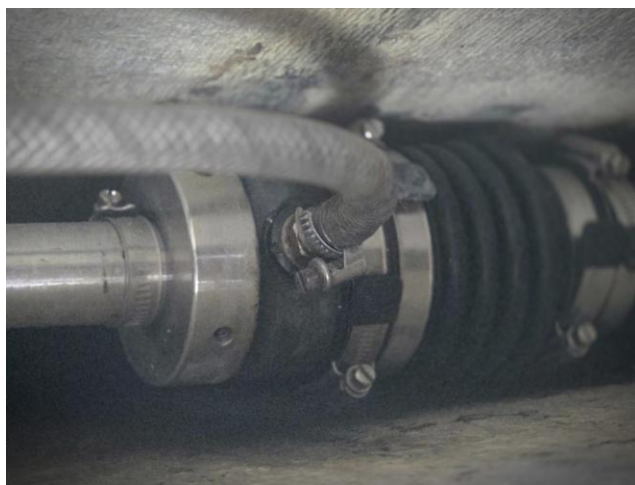
Shaft drive through a dripless shaft seal to a three-blade bronze propeller, estimated at 16-inch diameter by 14-inch pitch (no size marking on the propeller could be read). The dripless seal leaked on launching; the leak diminished considerably after the vessel was run in gear for about 20 minutes. It appears the drive shaft may require adjustment. Both are scheduled as a Recommend item; keep a close eye on the shaft seal.

**31** Dripless shaft seal — leaked on launch, diminished after 20 minutes in gear

| # | Item / location | Finding | Recommendation | Priority |
|---|---|---|---|---|
| 8 | Dripless shaft seal and shaft alignment | The dripless shaft seal leaked on launching; the leak diminished considerably after about 20 minutes run in gear. It appears the drive shaft may require adjustment. <i>(Photo 31)</i> | Inspect the seal bellows and rotor face, burp the seal, and check engine-to-shaft alignment at the coupling once the vessel has settled afloat. Replace the bellows if aged. Monitor the seal closely in the meantime. Reference ABYC P-6. | Recommend |

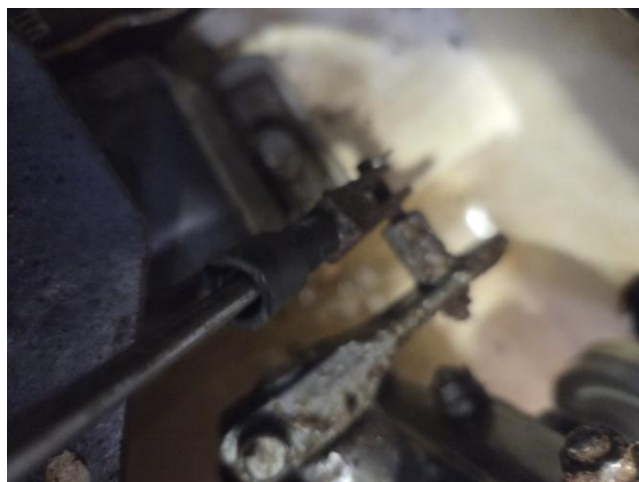
The throttle and shift control operated with difficulty, and the control connection at the transmission has severe corrosion. Both are scheduled as Priority items. Reference ABYC P-14.

**34** DEF Throttle / shift connection at the transmission severely corroded

| # | Item / location | Finding | Recommendation | Priority |
|---|---|---|---|---|
| 3 | <b>Throttle / shift connection at transmission</b> | The control-cable connection hardware at the transmission is severely corroded. See also the following item. <i>(Photo 34)</i> | Replace the corroded connection hardware (clevises, pins, clips and cable end fittings) and confirm full, positive engagement of forward, neutral and reverse. Reference ABYC P-14. | <b>Priority</b> |

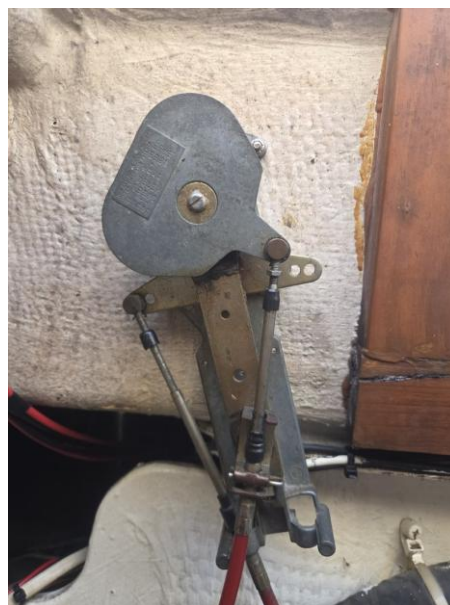
**35** DEF Throttle / shift mechanism requires adjustment, lubrication or replacement

| # | Item / location | Finding | Recommendation | Priority |
|---|---|---|---|---|
| 4 | <b>Throttle / shift control mechanism</b> | The throttle and shift lever operated stiffly and with difficulty. The corroded connection at the transmission (preceding item) is a probable contributor. <i>(Photo 35)</i> | Service the control head and cables: adjust and lubricate, or replace cables and control as required, so that the vessel can be shifted and throttled smoothly and positively. Reference ABYC P-14. | <b>Priority</b> |

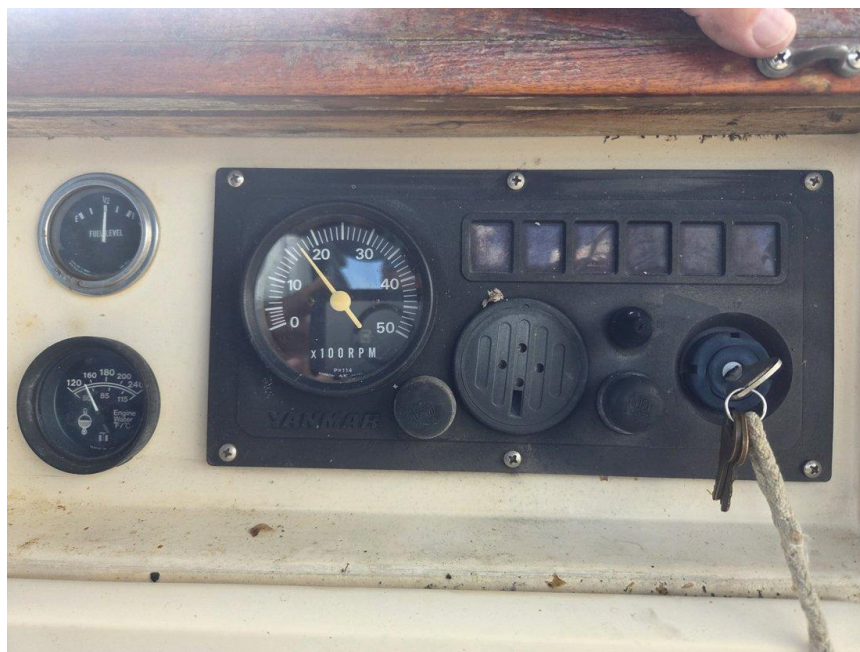
**36** Engine panel: start, tachometer, fuel gauge and engine temperature. No oil pressure gauge installed

No engine oil pressure gauge is installed; the engine panel provides a tachometer, temperature gauge, fuel gauge and warning lamps. Recommend fitting an oil pressure gauge so that pressure can be monitored, and trends observed, rather than relying on a low-pressure warning alone.

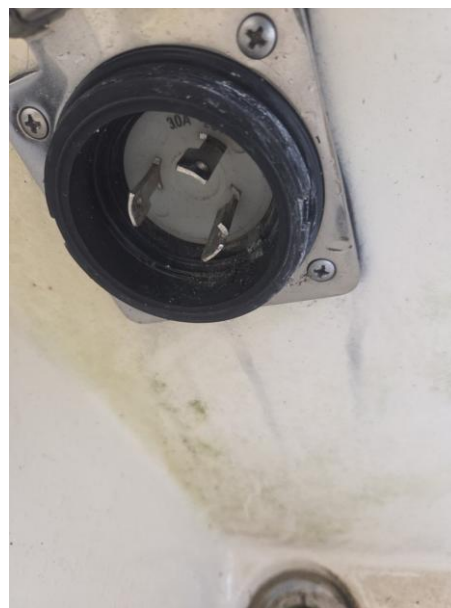
40 Shore-power inlet corrosion-free; no evidence of high heat or resistance

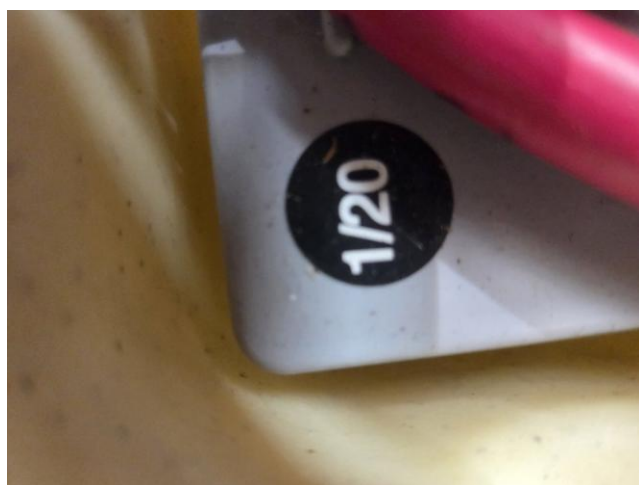
**43** DEF Batteries date-coded 1/2020 require replacement

| # | Item / location | Finding | Recommendation | Priority |
|---|---|---|---|---|
| 9 | Batteries dated 1/2020 | All four 6-volt GEL batteries are date-coded January 2020 and are beyond their typical service life. <i>(Photo 43)</i> | Replace both banks with matched batteries of a type suited to the charging equipment. Reference ABYC E-10. | Recommend |

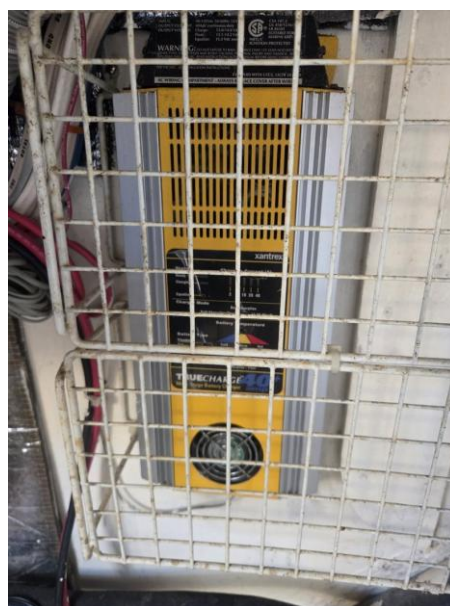
**44** DEF 120 VAC battery charger does not power up

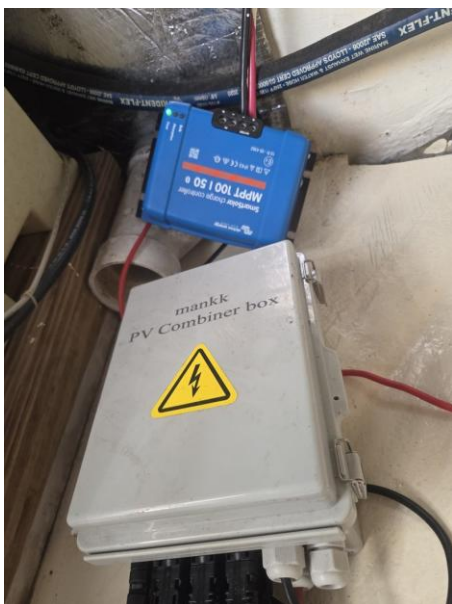
49 DEF Victron charge controller and PV combiner box not mounted, adrift

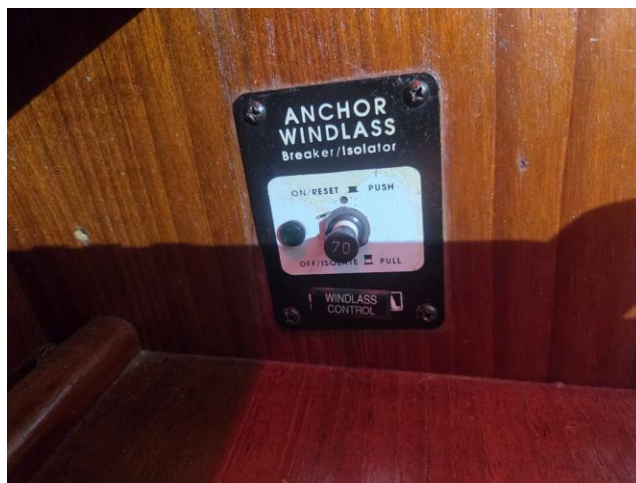
50 DEF Anchor windlass breaker; windlass removed and power cables adrift in the chain locker

Primary anchor: 40-lb galvanized steel CQR on the bowsprit roller. A spare anchor is provided aboard. The anchor shackle is not moused (Recommend). The anchor windlass has been removed and its power cables are adrift in the chain locker (Priority). Reference ABYC H-40.

| # | Item / location | Finding | Recommendation | Priority |
|---|---|---|---|---|
| 5 | <b>Anchor windlass removed — power cables adrift</b> | The anchor windlass has been removed. Its heavy-gauge power cables are loose and adrift in the anchor chain locker; the windlass breaker remains at the panel. <i>(Photo 50)</i> | Until a windlass is reinstalled, disconnect the cables at the source, insulate and cap the ends, and secure them clear of the chain. Reference ABYC E-11. Install a replacement windlass if one is wanted for the intended service. | <b>Priority</b> |

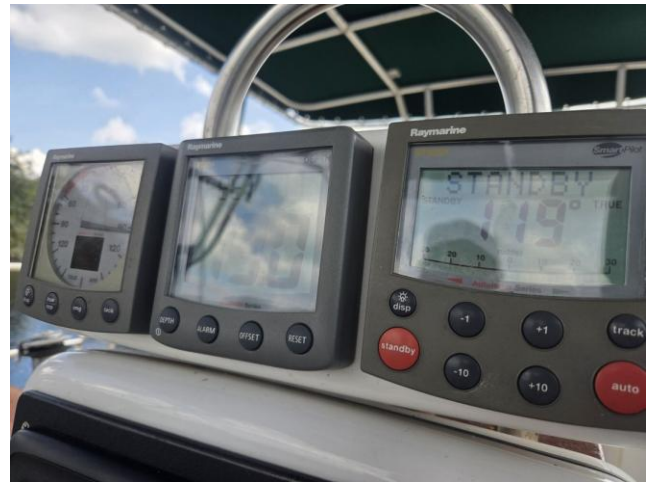
52 DEF All instruments power up; wind direction and speed transducers not mounted on the mast

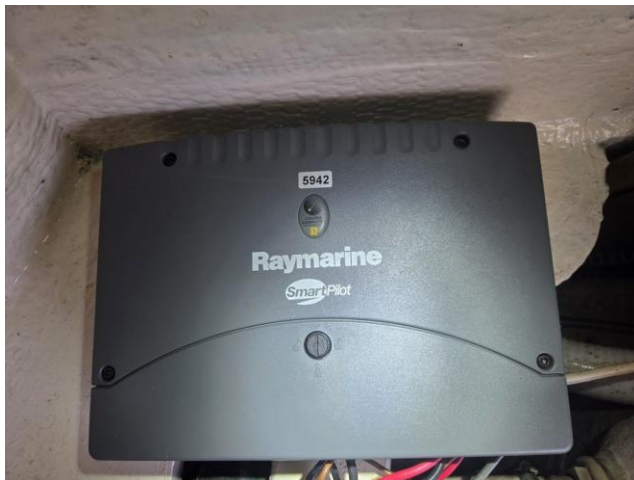
53 DEF SmartPilot autopilot requires adjustment

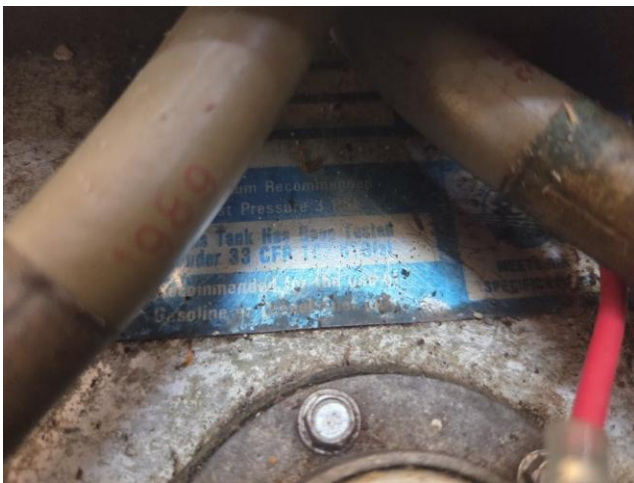
57 Fuel tank identification label present, not completely legible

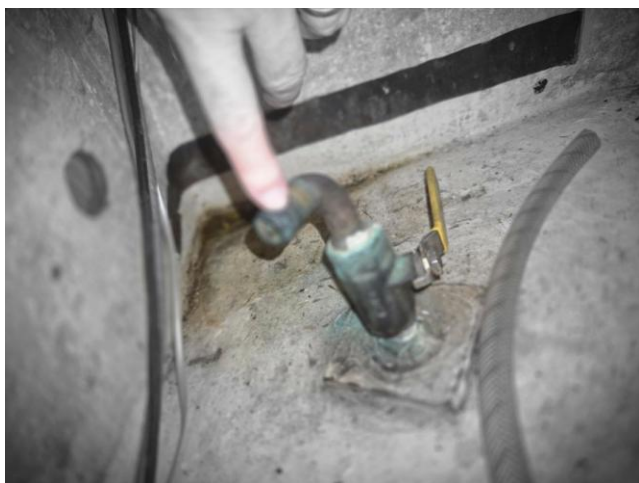
59 DEF Abandoned seacock is not plugged

| # | Item / location | Finding | Recommendation | Priority |
|---|---|---|---|---|
| 1 | <b>Abandoned seacock (below waterline)</b> | A disused bronze seacock remains in place with no hose attached and no plug or cap fitted. Should the valve be opened or fail, the vessel would be open to the sea. <i>(Photo 59)</i> | Remove the abandoned thru-hull and seacock and glass the hull penetration closed, or fit a proper bronze plug and cap and label the valve. Reference ABYC H-27. | <b>Priority</b> |

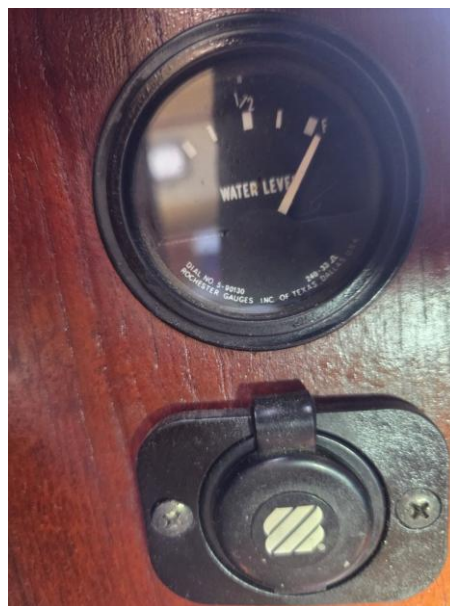
60 DEF Water tank gauge is not correct

| # | Item / location | Finding | Recommendation | Priority |
|---|---|---|---|---|
| 16 | Water tank gauge | The water tank gauge does not read correctly. <i>(Photo 60)</i> | Repair or replace the sender and gauge. | Monitor |

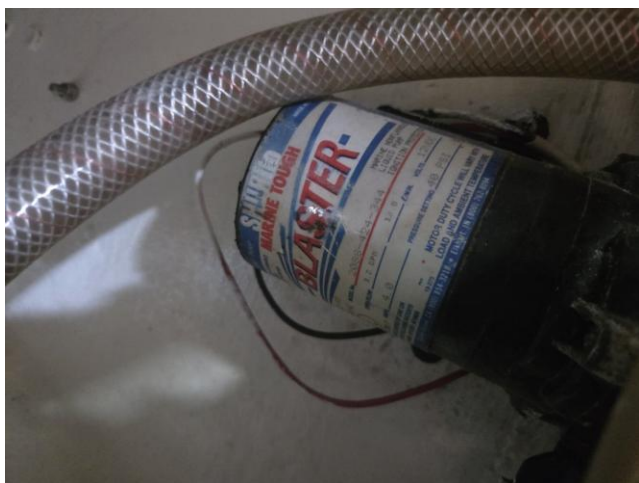
61 DEF Raw-water washdown pump inoperative

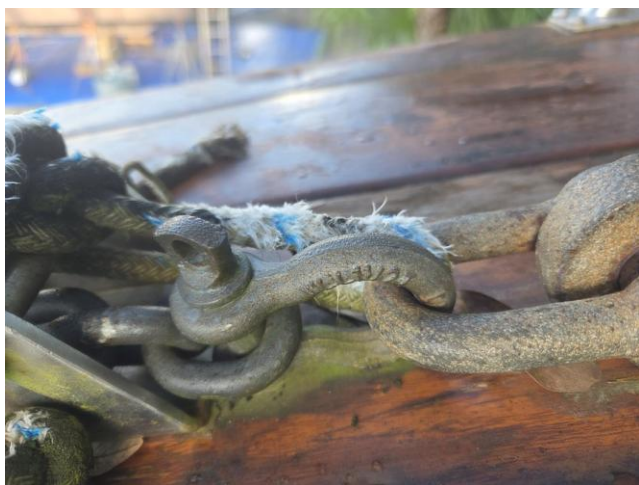
67 DEF Anchor shackle has no safety wire (mousing)

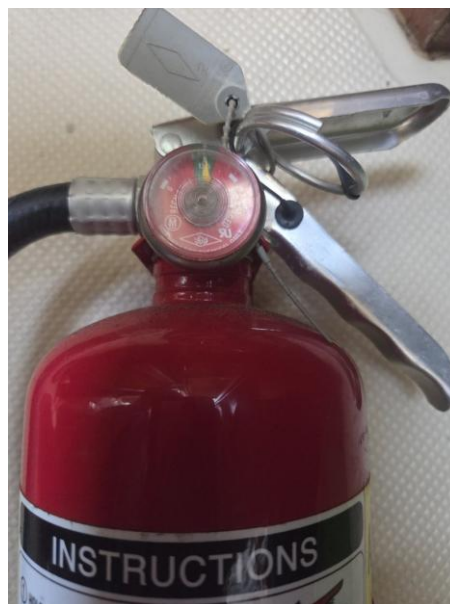
68 DEF All hand-held fire extinguishers are expired

| # | Item / location | Finding | Recommendation | Priority |
|---|---|---|---|---|
| 2 | <b>Portable fire extinguishers</b> | All hand-held fire extinguishers aboard are expired per their inspection tags, although the gauges read in the charged range. <i>(Photo 68)</i> | Replace with, or have serviced and re-tagged, the number and class of USCG-approved extinguishers required for a vessel of this length (46 CFR 25.30; ABYC A-4). Confirm before the vessel is operated. | <b>Priority</b> |
