1998 52' / 15.8m Viking Princess Flybridge Sport Cruiser

"Santasha"

Report of Marine Survey

Date Of Survey: 06/15/2026

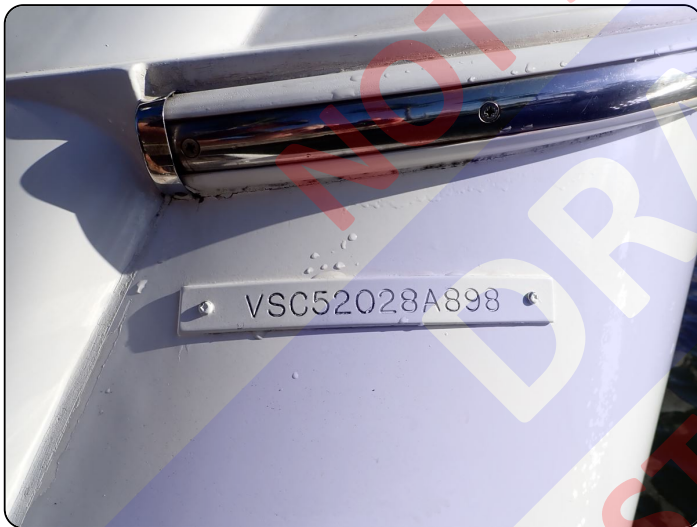
The vessel's HIN (Hull Identification Number) displayed on the starboard transom DID match the HIN recorded with U.S.C.G. Documentation. (VSC52028A898)

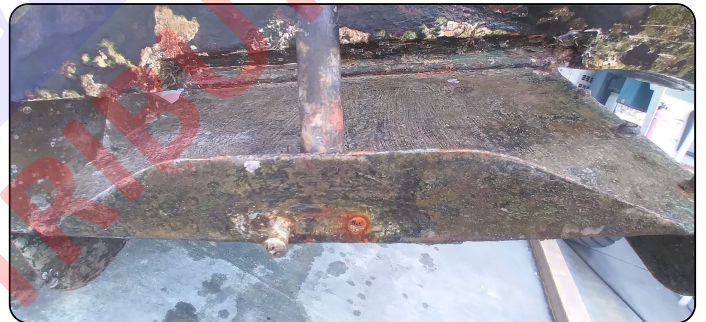
The hull was equipped with raw water strainer screens and scoops. Monitor/clean often. Some minor marine growth sighted.

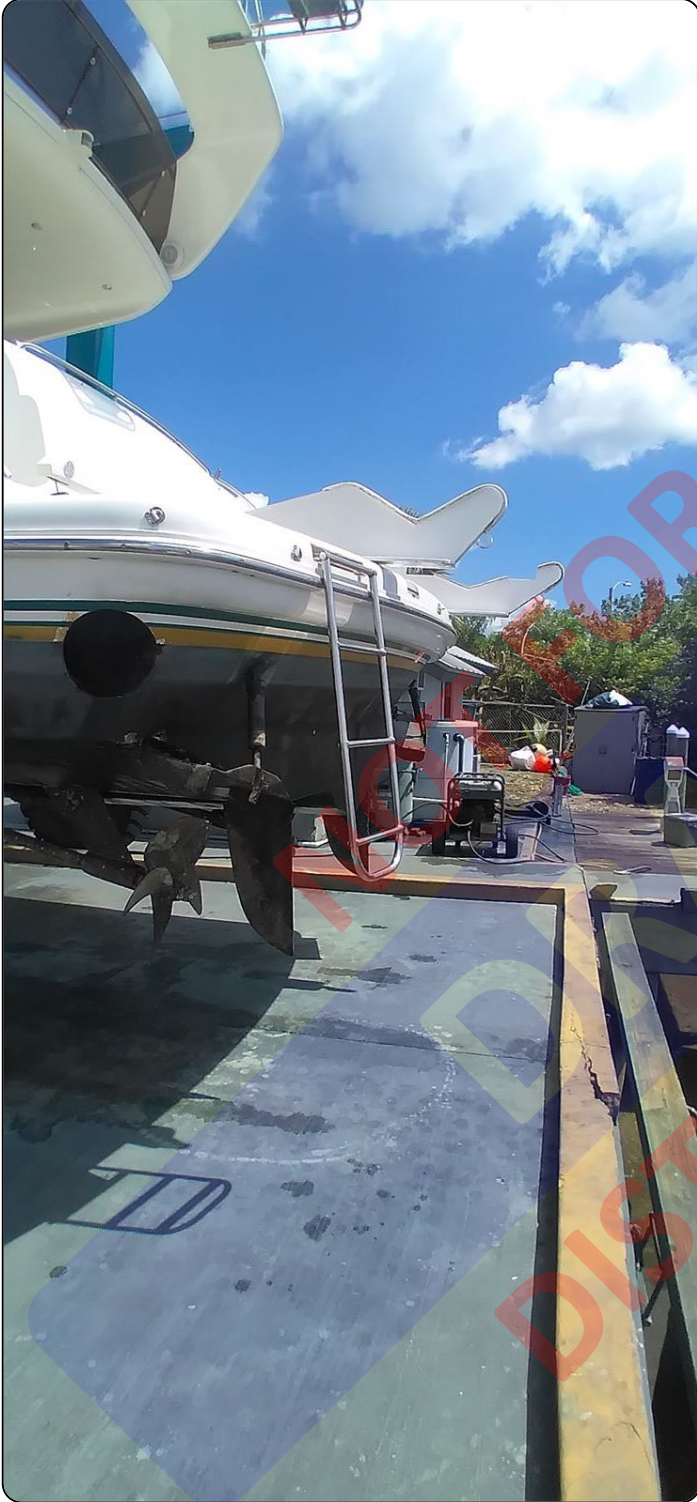
Telescoping stainless steel boarding ladder installed at the swim platform. Solid mounting. Weight tested. No significant corrosion or wear.

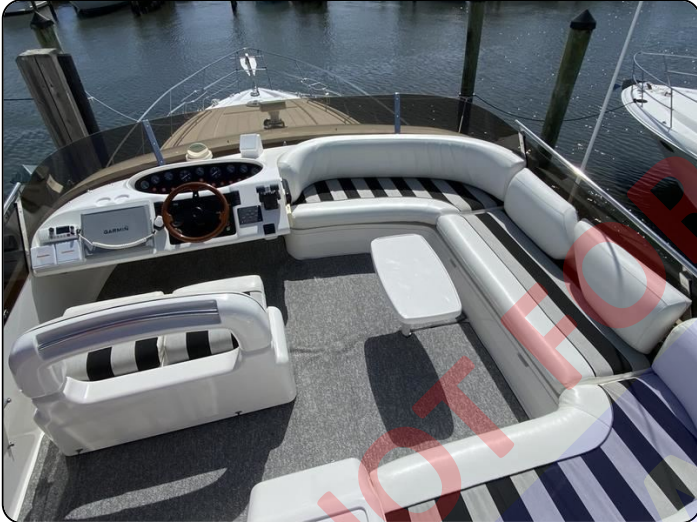
The vessel's exterior soft-goods appeared serviceable with no significant weathering.

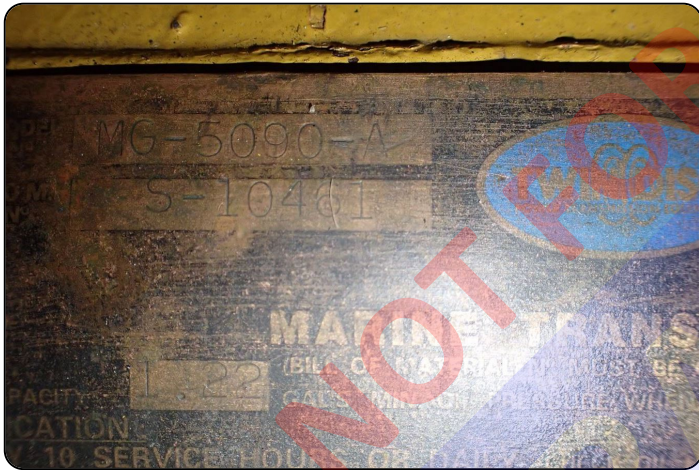
Twin Disc Drive system operated during sea trial with no exceptions. See Engine surveyors report on drive shaft connections and oil levels in the transmissions.

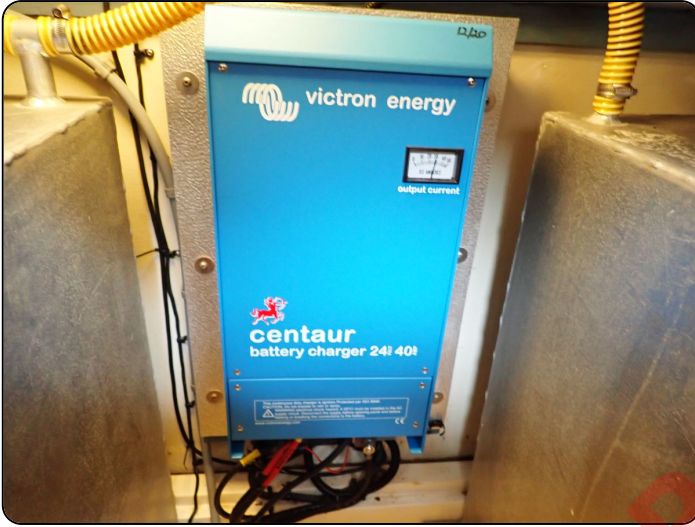
Victron Energy Centaur - 24 volt / 40 amp. Battery Charger. Powers up. The output at the battery terminals was tested at +.7 Volts with Ideal Multi meter.

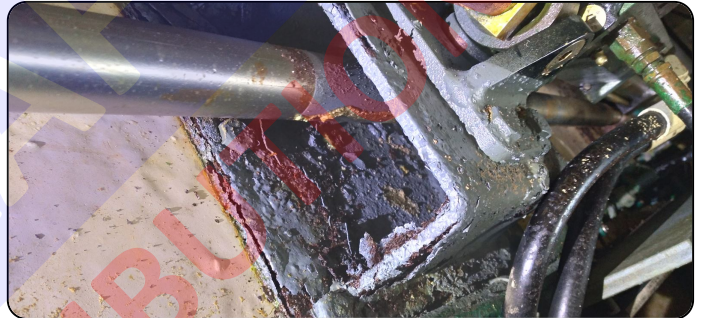
55 lb. Delta Galvanized Plow Anchor with approx. 40 ft galvanized chain, 200 ft 7/8" 3 strand nylon line & Fortress FX-37 Danforth aluminum anchor with 20 ft. galvanized chain & 200ft 7/8" 3 strand nylon line. 24 vdc Lewmar Winch operated from handheld remote controls at bow. Anchor control at the lower helm operated. The anchor winches friction brake pad was perished. Anchor would free fall if released.

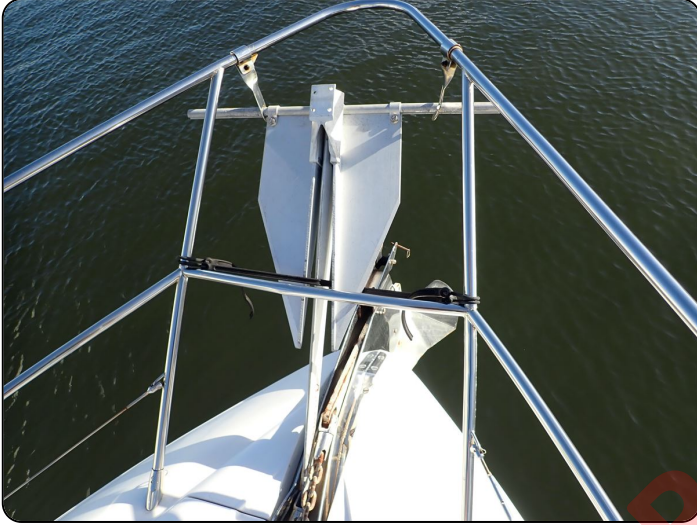
10Mm Galvanized chain. Chain corrosion appears excessive.

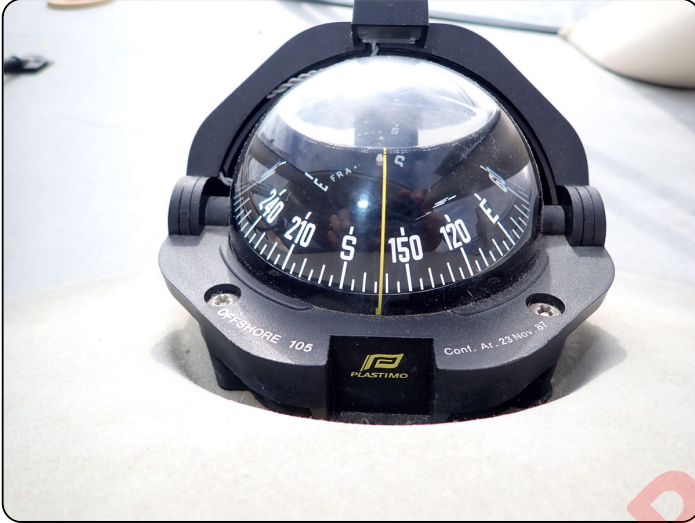
Azimuth 1000 digital compass upper helm appears accurate. Plastimo 4" black compass lower helm appears accurate. No compass dial lights sighted.

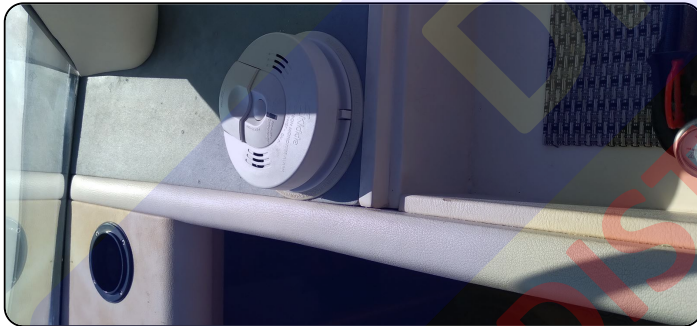
Two (2) Smoke Detectors. Test sounded.
