## TB MARINE SURVEYORS

### PRE-PURCHASE CONDITION & VALUE SURVEY

1990 Island Packet 35 Cutter “Nirvana”

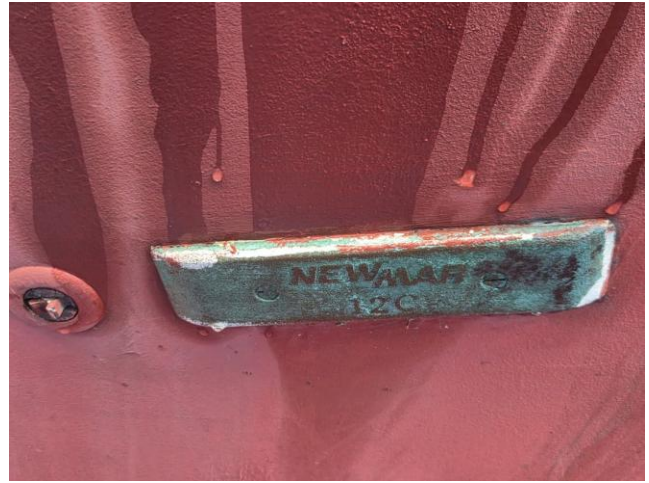
**11** Bonding ground plate clean

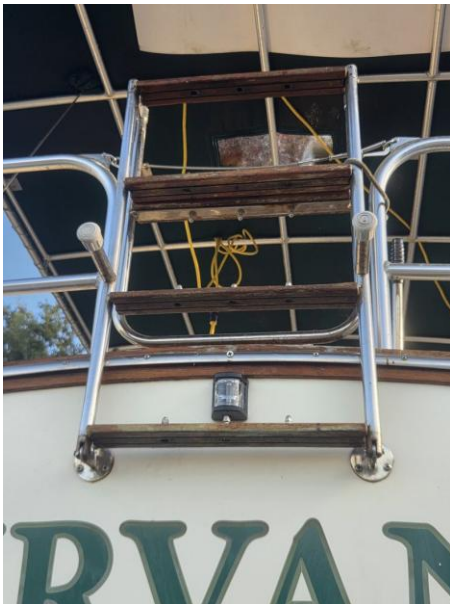
14 Boarding ladder well secured

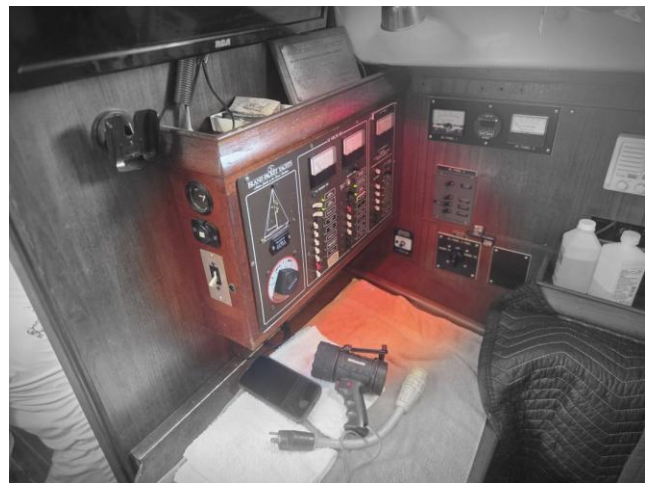
17 Chart table and main electrical panel

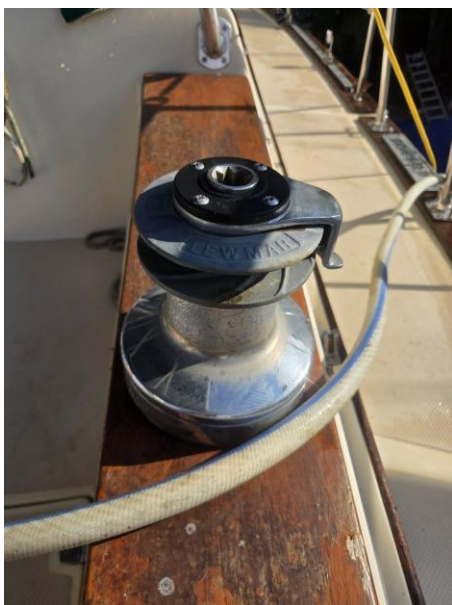
**22** Sail rigging and tackle appeared in good condition and recently serviced

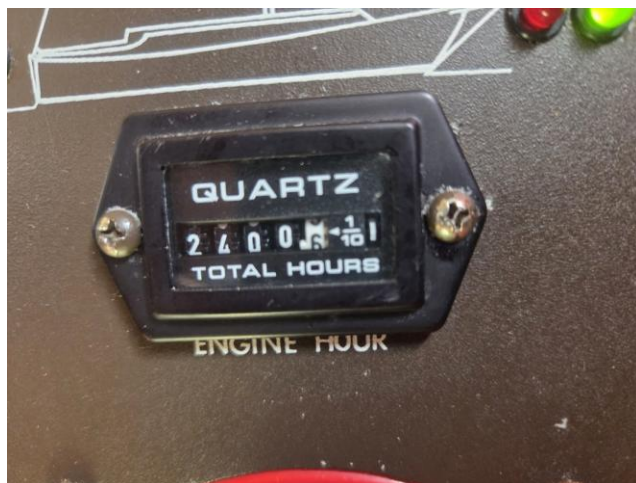
**25** Panel engine hour meter — 2,400.6 hours

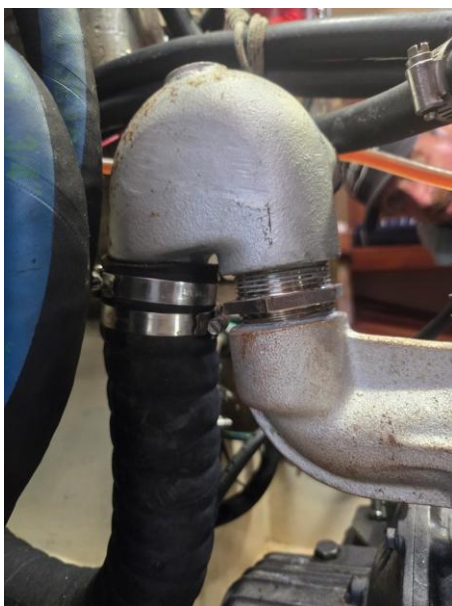
**28** Engine exhaust well secured and leak-free

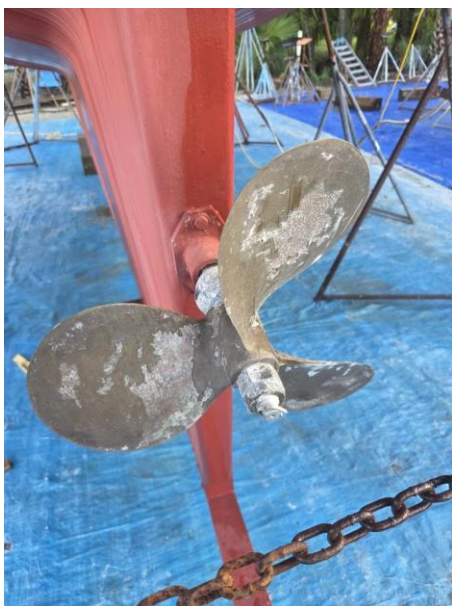
The rudder appeared in very good condition and operated through its full range. The three-blade bronze propeller (estimated 16 x 14; no size marking was legible) showed no significant impact damage or corrosion.

**32** Three-blade bronze propeller (est. 16 x 14; no legible marking); no significant impact damage or corrosion

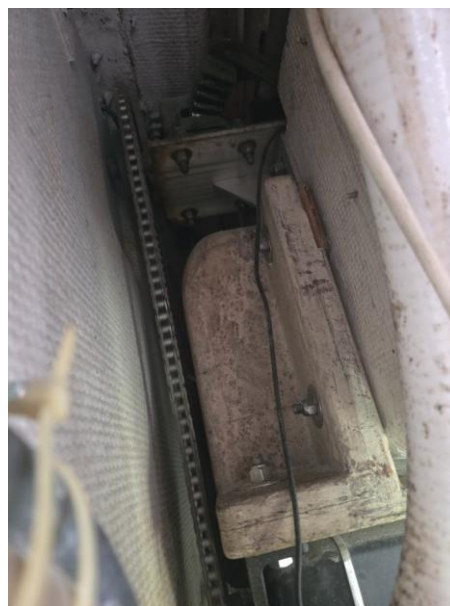
**33** Autopilot drive appears well adjusted and lubricated

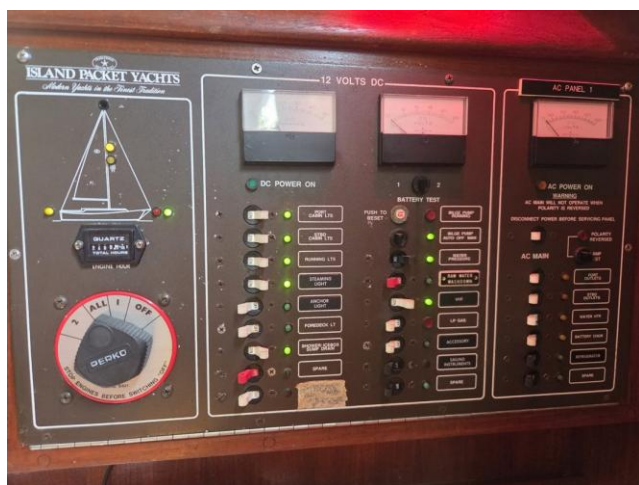
37 Main electrical panel; battery switch readily accessible

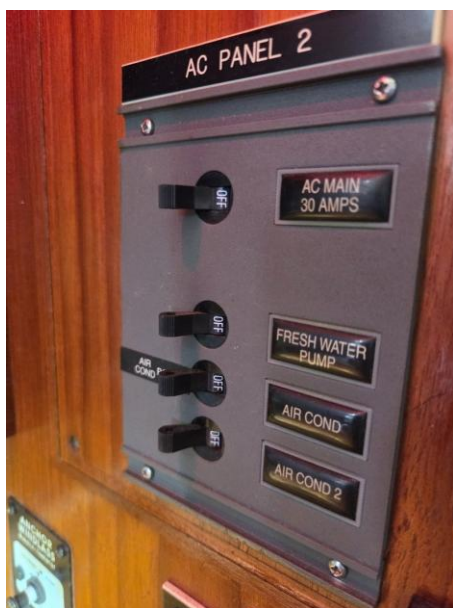
39 AC panel 2 — all circuits well marked

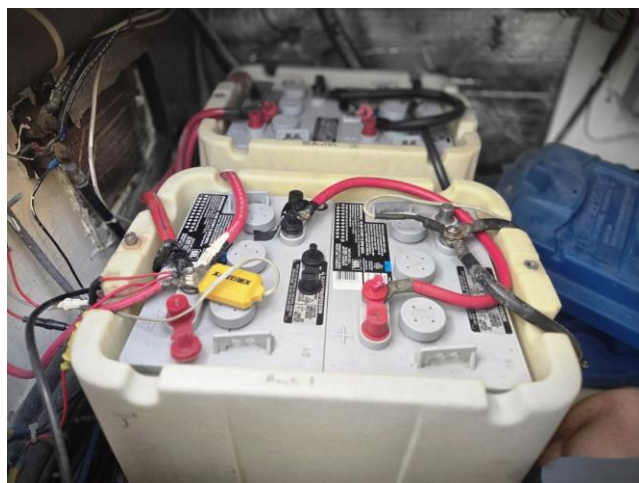
**41** Batteries in marine-grade, non-conductive boxes with protective covers, per ABYC

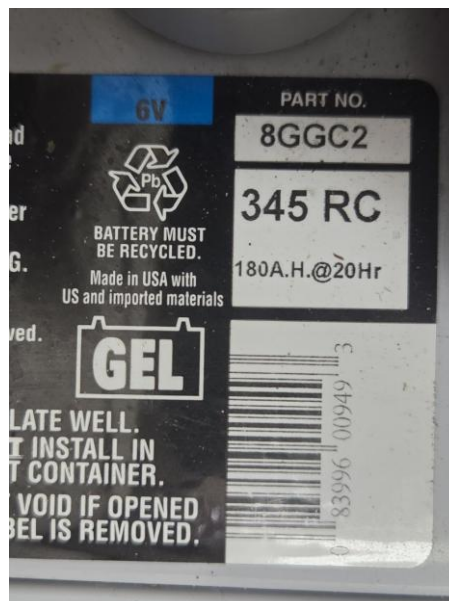
**42** 6-volt GEL battery, 180 Ah — two in series in each enclosure

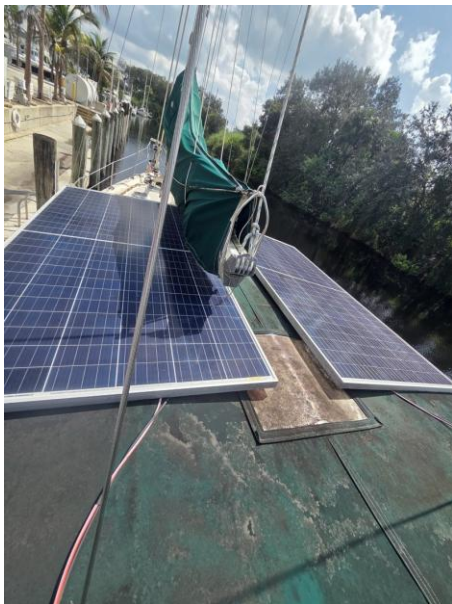
47 Solar panel arrangement

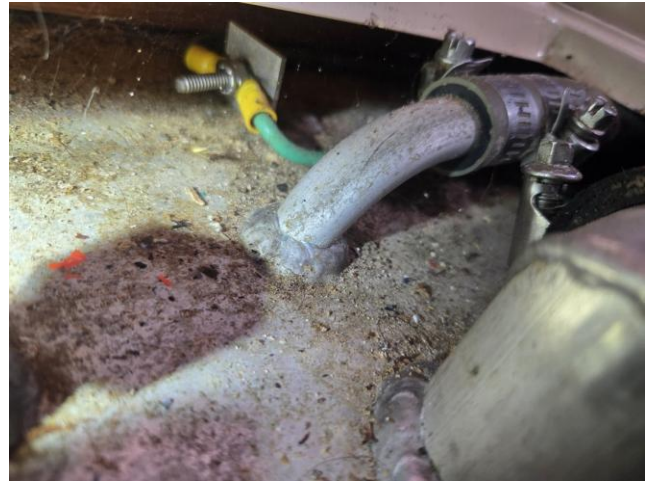
56 Fuel tank bonding terminal connection well established

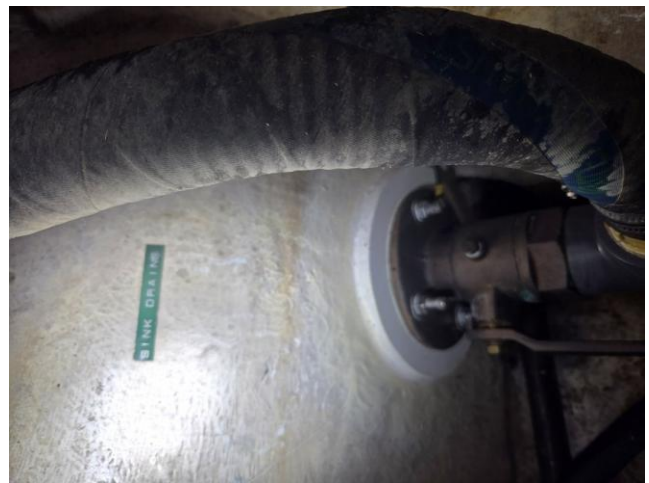
58 Seacocks operate open and closed — sink drain seacock shown
