## TB MARINE SURVEYORS

### PRE-PURCHASE CONDITION & VALUE SURVEY

1990 Island Packet 35 Cutter “Nirvana”

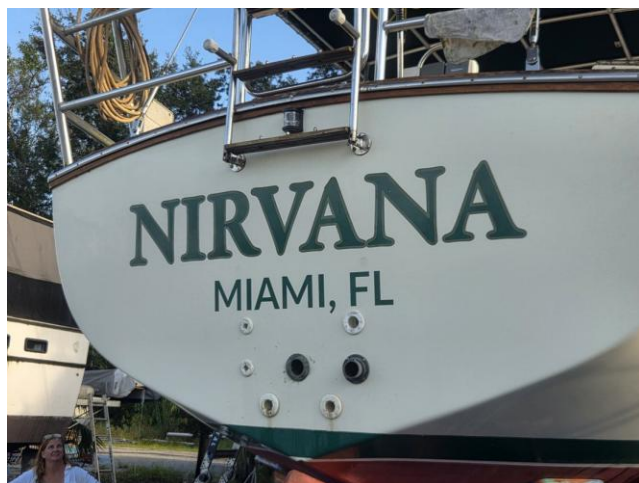
01 Vessel name and hailing port on the transom

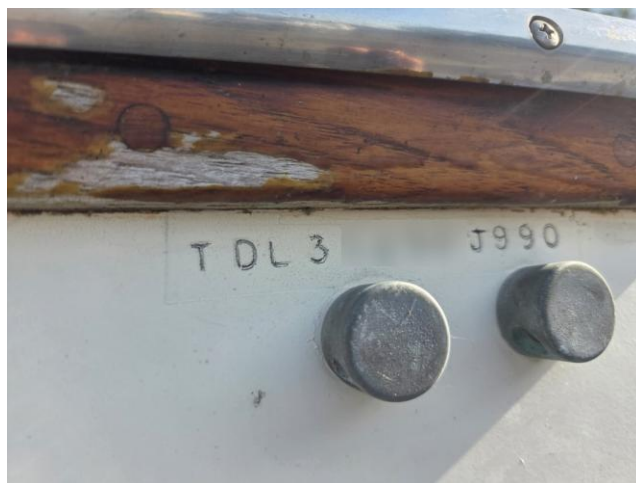
02 Hull Identification Number TDL35...J990 on the transom

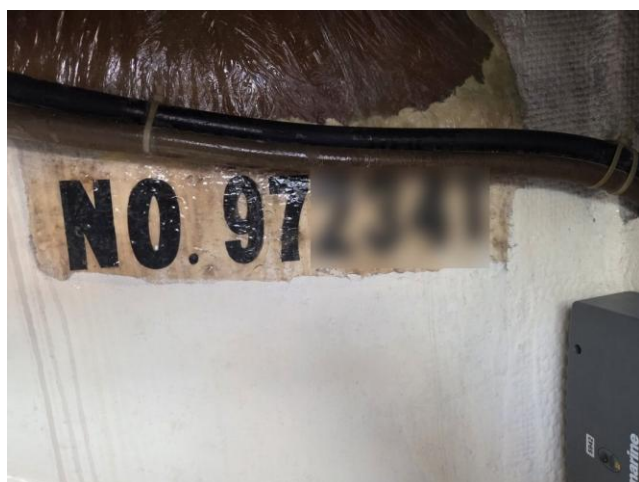
03 USCG Official Number permanently marked inside the hull

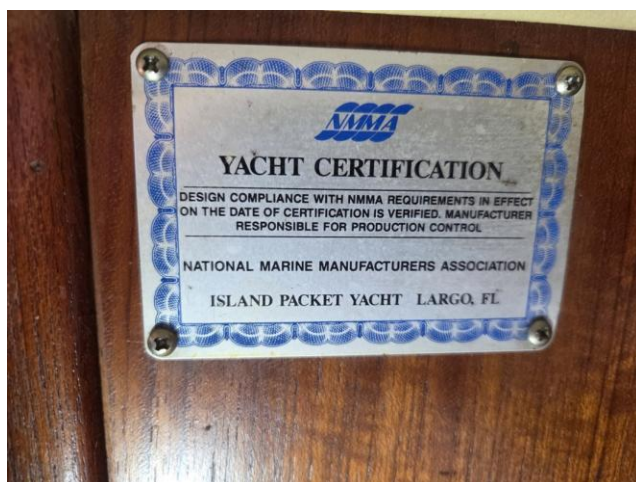
04 NMMA Yacht Certification plate, Island Packet Yacht, Largo, FL

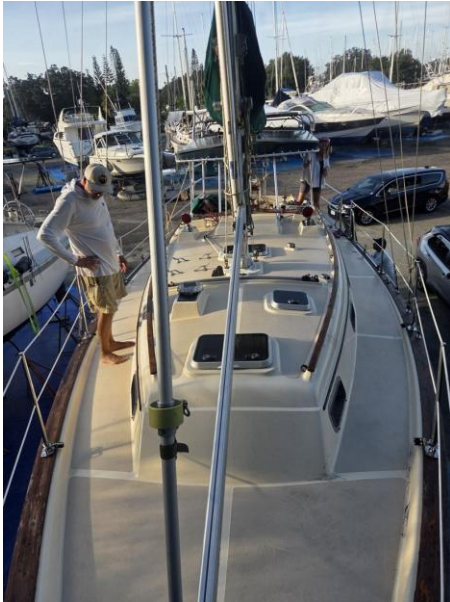
**12** Deck profile looking aft

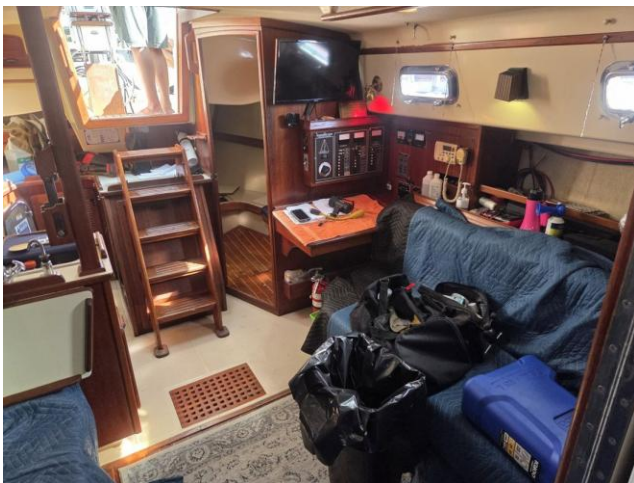
The vessel interior is in above-average condition. The interior teak flooring, cabinetry and trim are in average condition with no abnormal wear and tear, and are all restorable to like-new condition.

16 Main salon

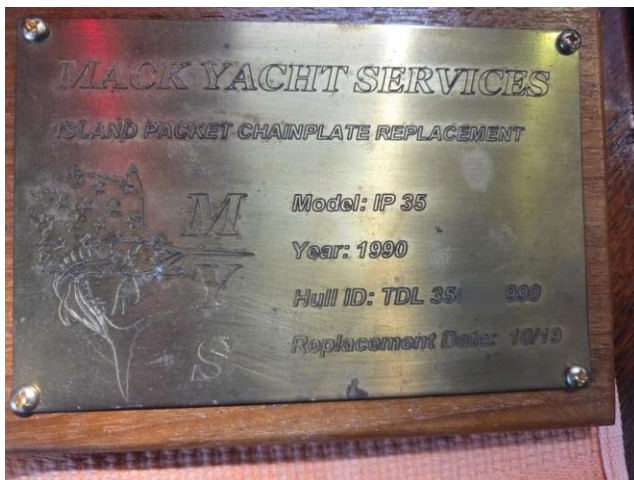
The original chainplates on the Island Packet 35 are a well-known inspection point for the model, and chainplate replacement is a recurring line item in the sales history of these vessels. On this vessel all six chainplates were replaced by Mack Yacht Services, Stuart, Florida, in July 2019, including the associated carpentry, electrical, glass work and varnish (invoice 1255, \$13,000 for the chainplate work). The stemhead fitting and headstay fittings, top and bottom, were replaced at the same time. A bronze plaque aboard records the replacement (Model IP 35, Year 1990, HIN TDL35•••J990, replacement date 10/19).

18 Chainplate replacement plaque — Mack Yacht Services, replacement date 10/19

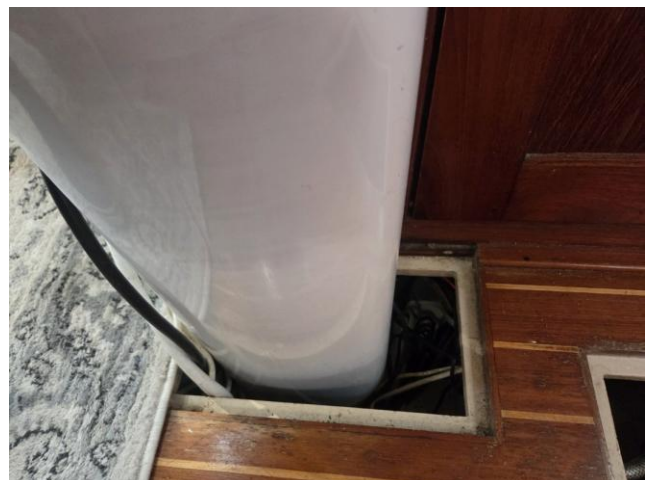
19 Mast is keel-stepped

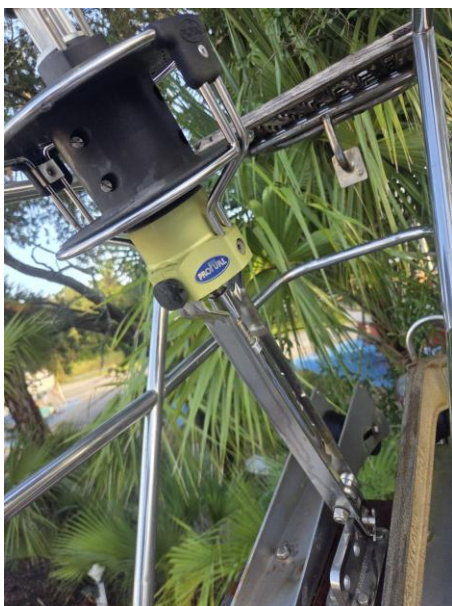
**20** Headsail roller-furling mechanism appears in serviceable condition

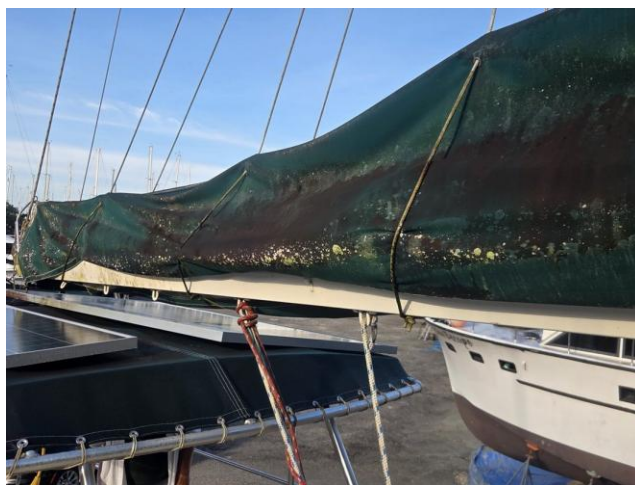
**21** Mainsail protected by a lazy-bag sail cover

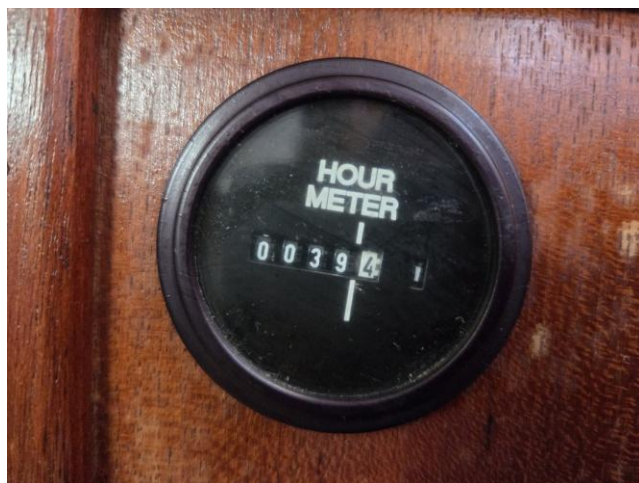
**26** Second hour meter — approximately 394 hours (may indicate hours since rebuild)

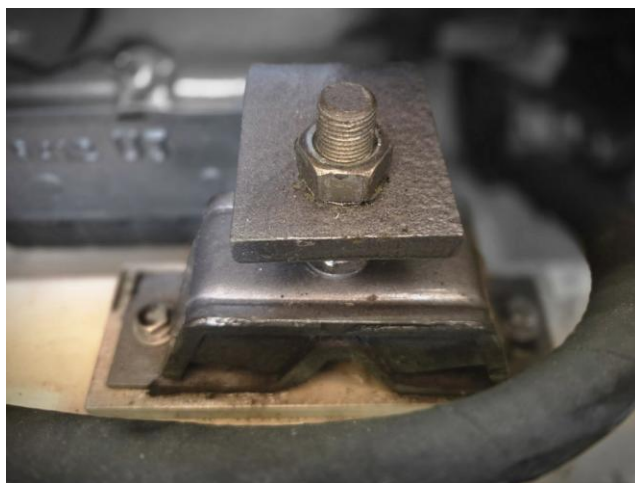
**27** Engine mounts appear like new

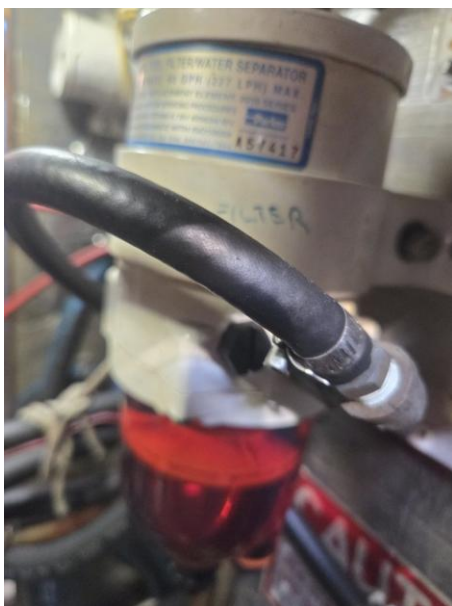
**30** Racor fuel filter / water separator clean

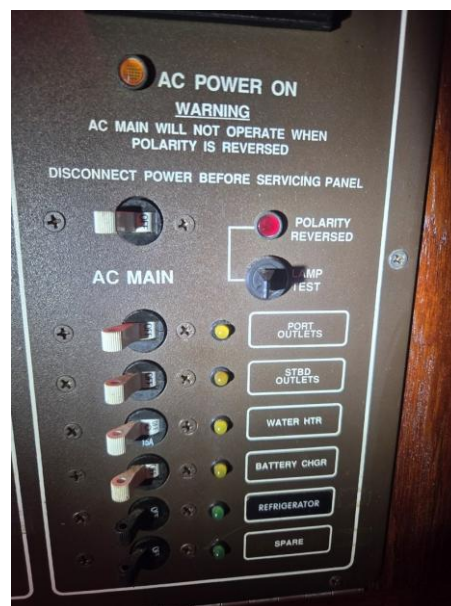
38 AC main panel well marked, with reverse-polarity indicator

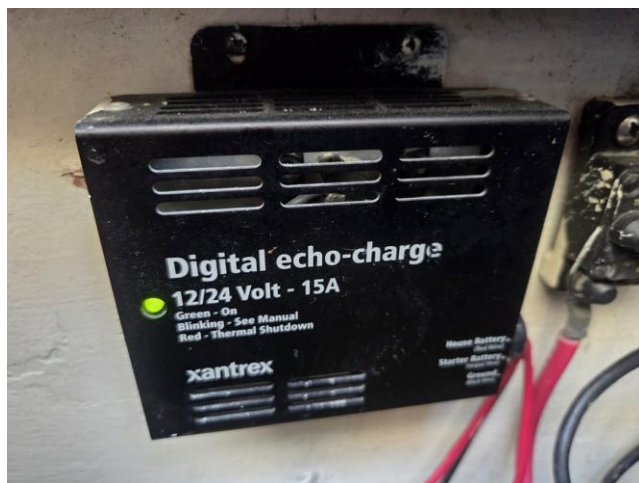
45 Xantrex Digital Echo-Charge — status light green

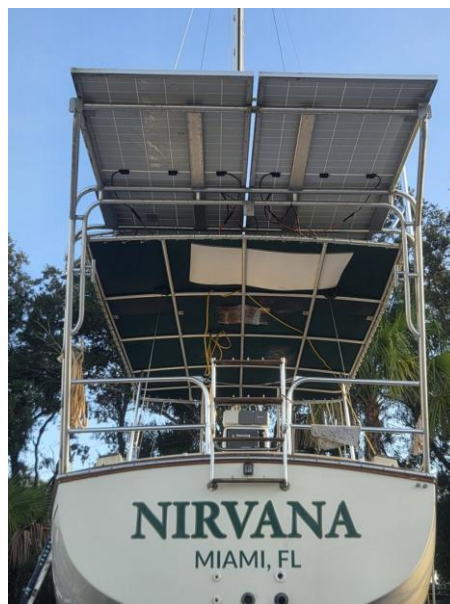
46 Stern profile — solar panel support frame very secure and well designed

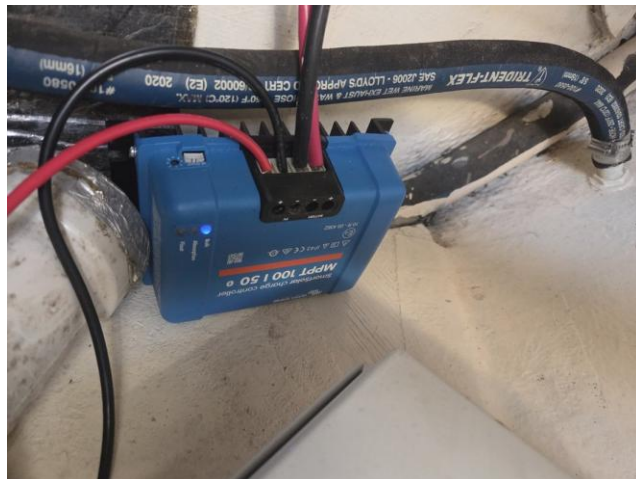
48 Victron SmartSolar MPPT controller operating as intended

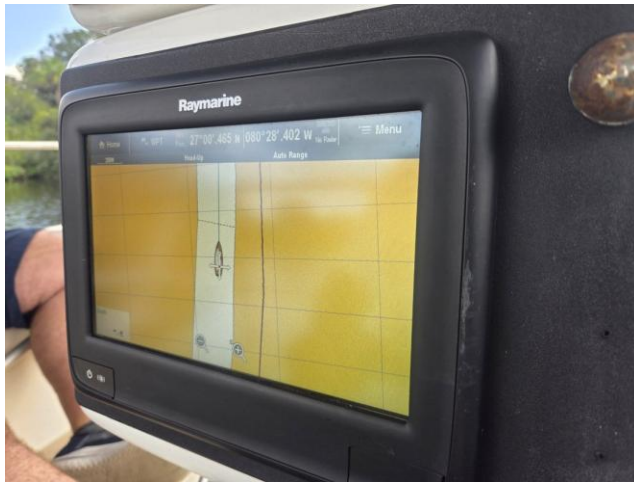
51 Raymarine chartplotter powers up

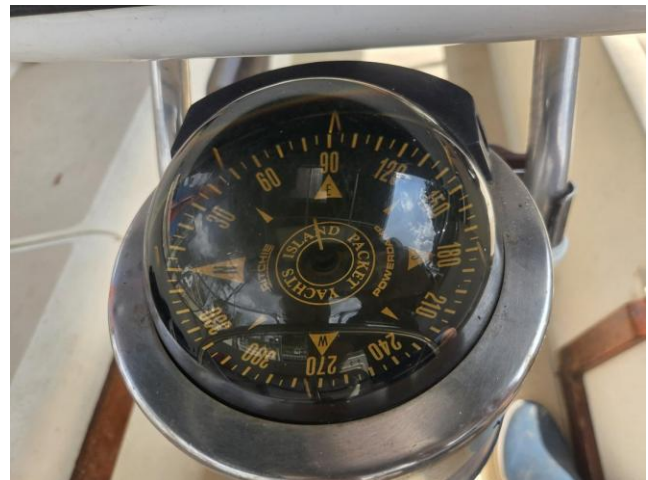
54 Magnetic compass appears accurate

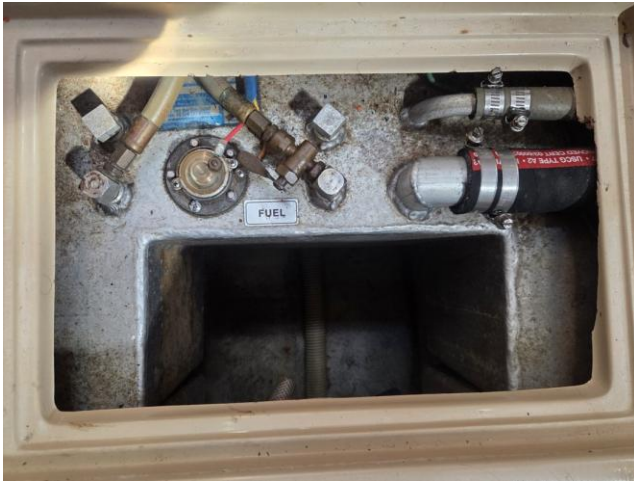
55 Fuel tank: all hoses double-clamped USCG Type A1; tank securely framed in

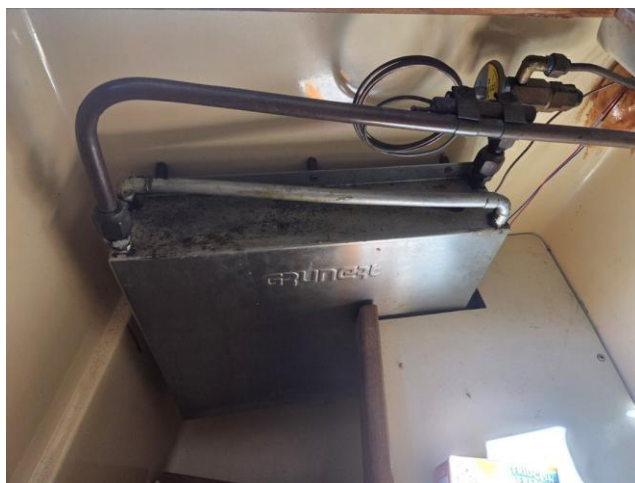
62 Galley refrigerator / freezer operates on 120 VAC shore power only

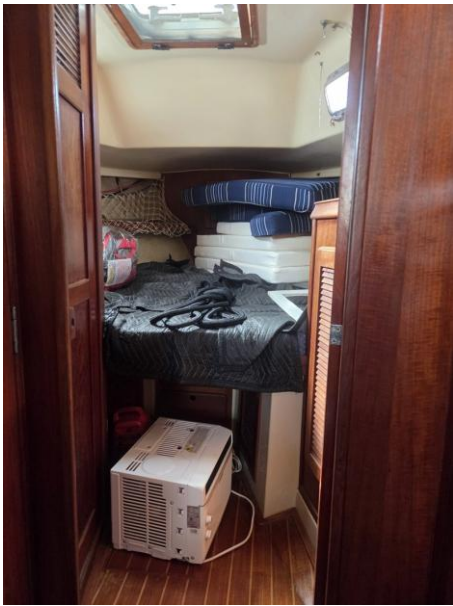
64 Aft cabin. Portable household air conditioner present, not operated

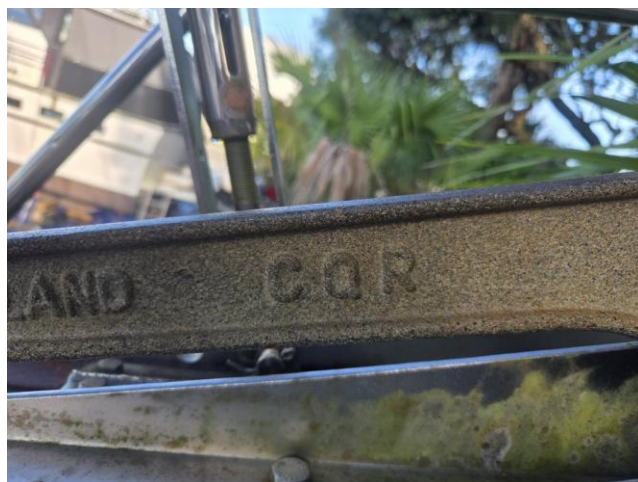
Primary anchor: 40-lb galvanized steel CQR on the bowsprit roller. A spare anchor is provided aboard. The anchor shackle is not moused (Recommend). The anchor windlass has been removed and its power cables are adrift in the chain locker (Priority). Reference ABYC H-40.

65 40-lb galvanized steel CQR anchor

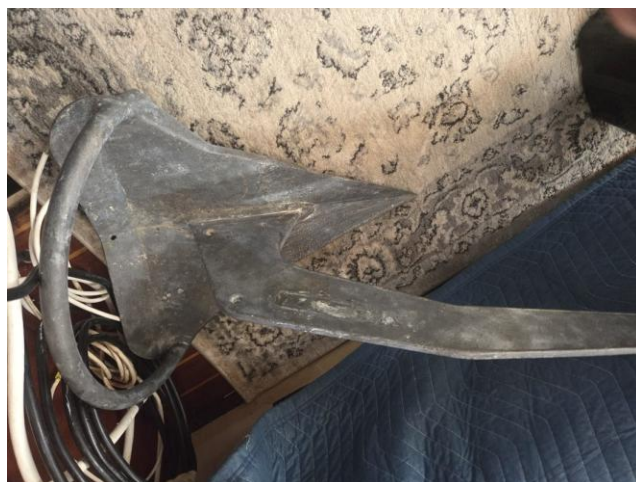
66 Spare anchor provided

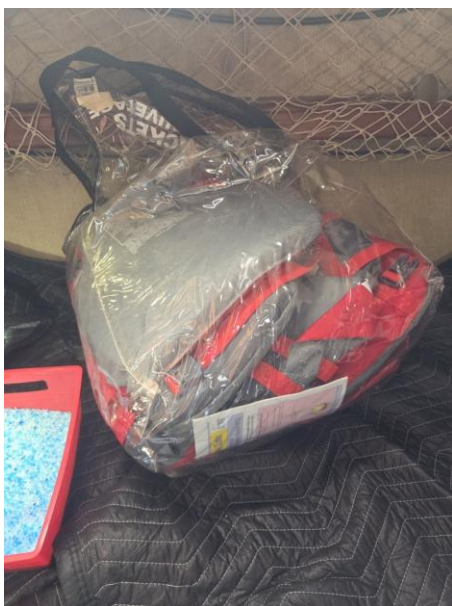
69 USCG-approved PFDs provided with the sale

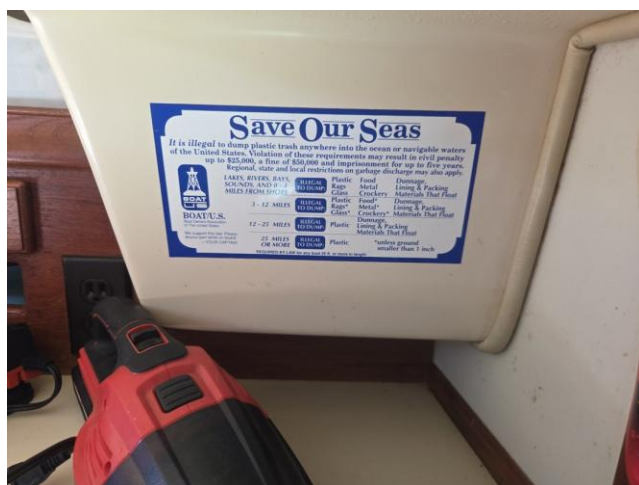
71 USCG garbage disposal placard posted

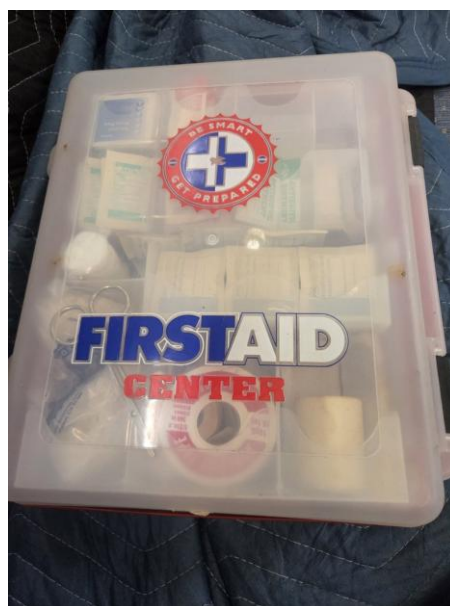
72 First aid kit aboard
